## **Appendix A      Coastal Processes Study**

## **Sandy Point/Conroy Park Coastal Process Study**

Prepared for Port Stephens Council

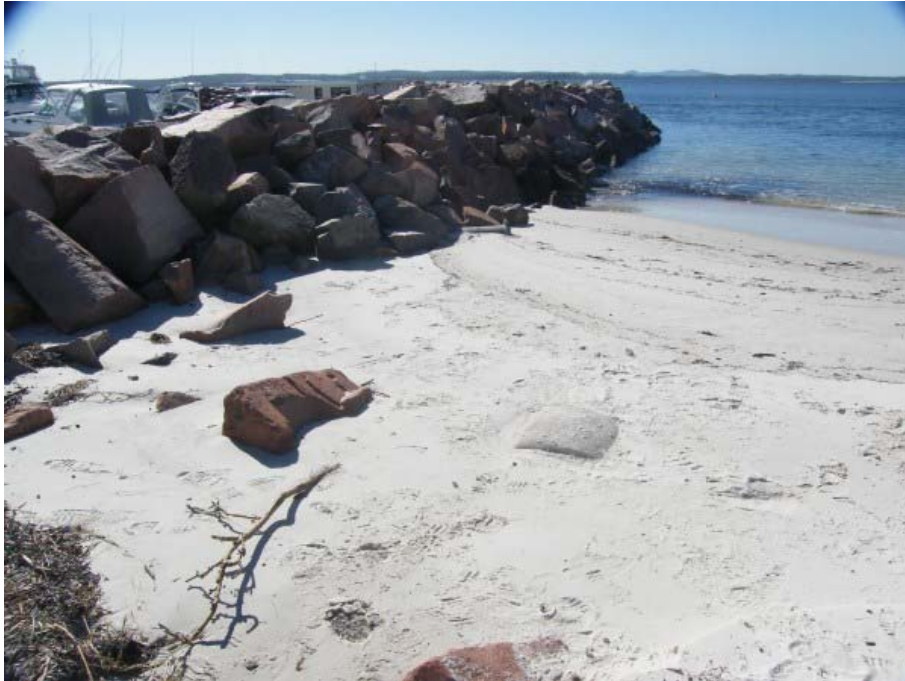
**Figure 2** Western end of Precinct 1. Sand accretion against the Anchorage marina wall is burying stormwater outlets. *Photo Source: D Lord, 8<sup>th</sup> May 2015*

No foreshore protection works are required to maintain development and crown land within this precinct. The major issues relate to the stormwater drainage outlets (3 of) which are affected by sedimentation. The sand build up also provides an opportunity to source sand on a regular basis which may be transferred to other locations along the southern Port Stephens foreshores east of this location. The original design and approval of for The Anchorage predicted this sand accretion and beach realignment and envisaged the relocation of this sand to address the possible impacts on the stormwater system and to prevent the “loss” of a valuable sand reserve from the active beach system.

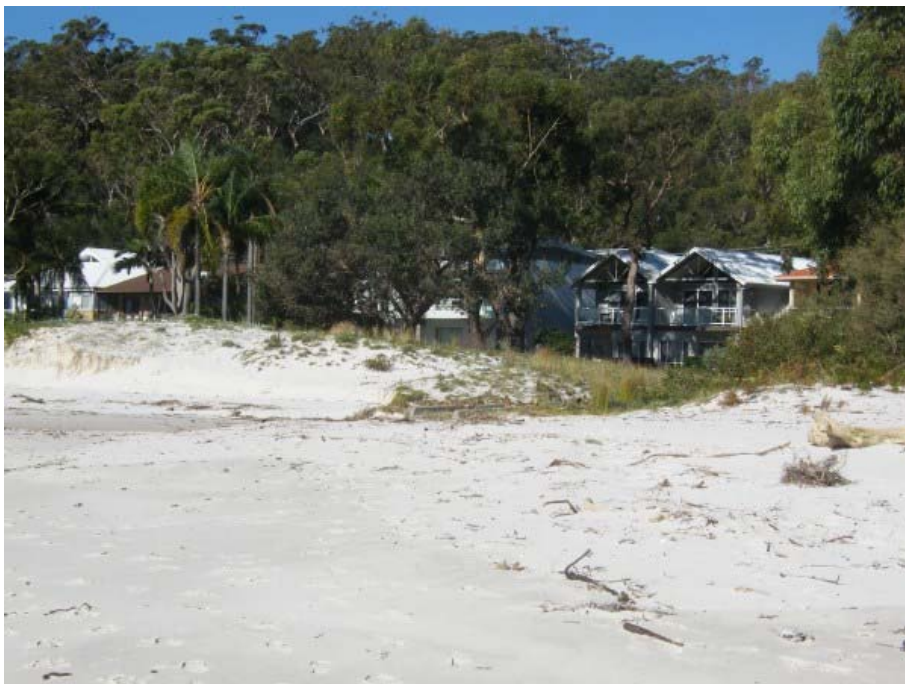
**Figure 3** Eastern end of Precinct 1. Sand accretion extends to the west of the stormwater drain across Corlette Point Park. *Photo Source: D Lord, 8<sup>th</sup> May 2015*

The amount of accretion over the past two decades decreases with distance east. At the stormwater outlet across Corlette Point Park the accretions is now well seaward of the constructed headwall at the back of the beach. The water discharges across the beach, scouring a narrow channel following rainfall. The headwall is currently around 25m from the high water mark. The sand build-up decreases further to around 0m approximately 75m east of the stormwater outlet (adjacent to #78 Sandy Point Road and the erosion of the foreshore and realignment of the beach dominate from that location to the east.

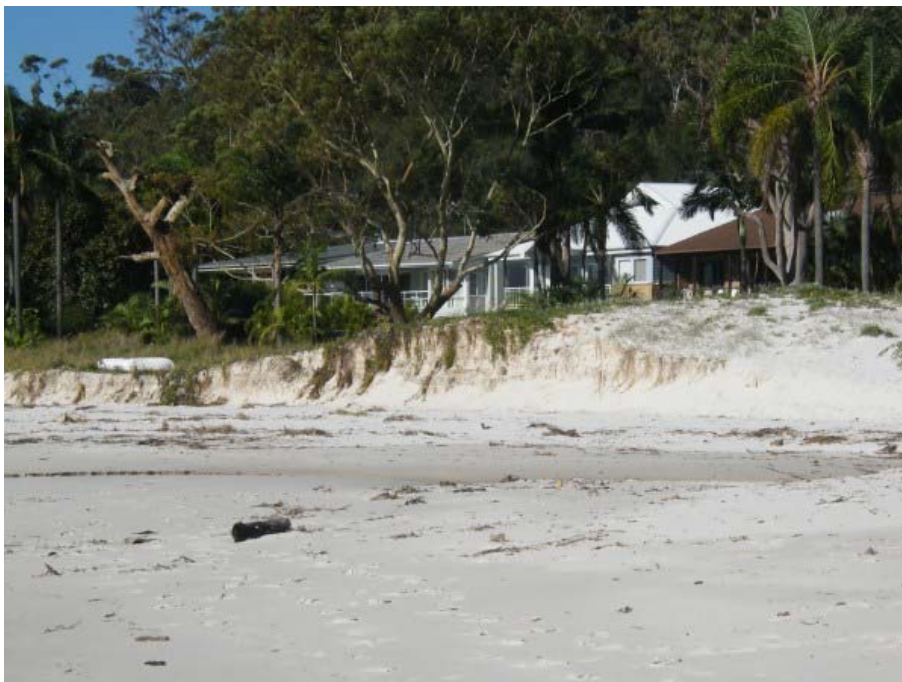
**Figure 4 Western end of Precinct 2 where accretion of the beach finishes east of the stormwater outlet and erosion of the back beach commences through to Conroy Park. Photo Source: D Lord, 8<sup>th</sup> May 2015**

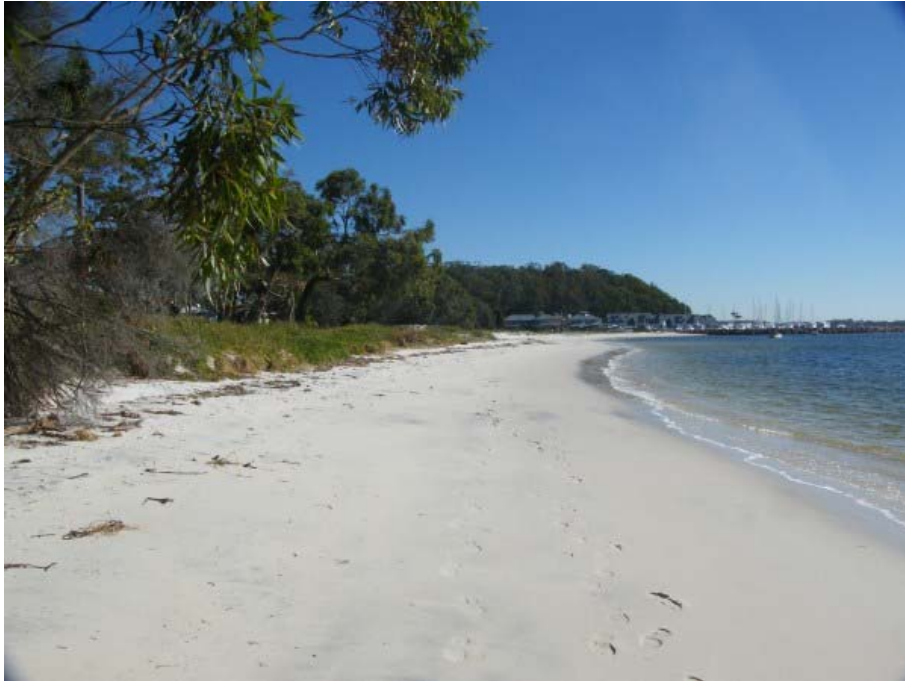
**Figure 5      Looking west along precinct 2 from Conroy Park. A sandy beach remains at mid to low tides and is a popular walking area between Conroy Park and the Anchorage.**

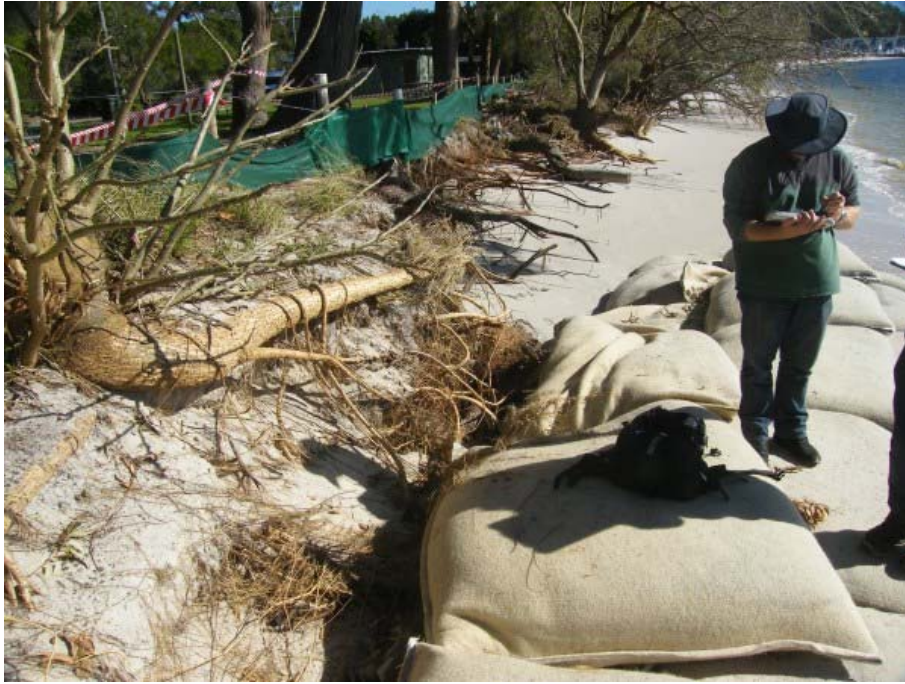
**Figure 6** Precinct 2 eastern end. Geotextile containers have been employed for emergency beach protection along the eastern end of Conroy Park. Increased erosion west of the end of the protection is evident. Additional containers have been placed to extend the wall since this photo. There is little sandy beach width remaining at this location and no beach at mid to high tides. Access to the beach from the park has been affected.

Recently, the major concern has been the erosion of vegetation through Conroy Park with the loss of eucalypts along the shoreline and coral trees which are valued for their summer shade in the reserve. Access to the Beach directly from the park has been comprised although pedestrian access from Conroy Park to Corlette Point Park along the waterfront reserve remains. Council has undertaken emergency foreshore protection through two campaigns, installing geotextile containers as permitted by the current NSW Government guidelines for emergency beach management. These have provided limited protection but do relocate the increased erosion to the western end of the completed wall section (end wall effects). This is evident at Conroy Park where erosion continued to the west of rock protection works prior to the installation of the geotextile bag protection. Again an increase in erosion was evident at the western, unprotected end of the geotextile bags.

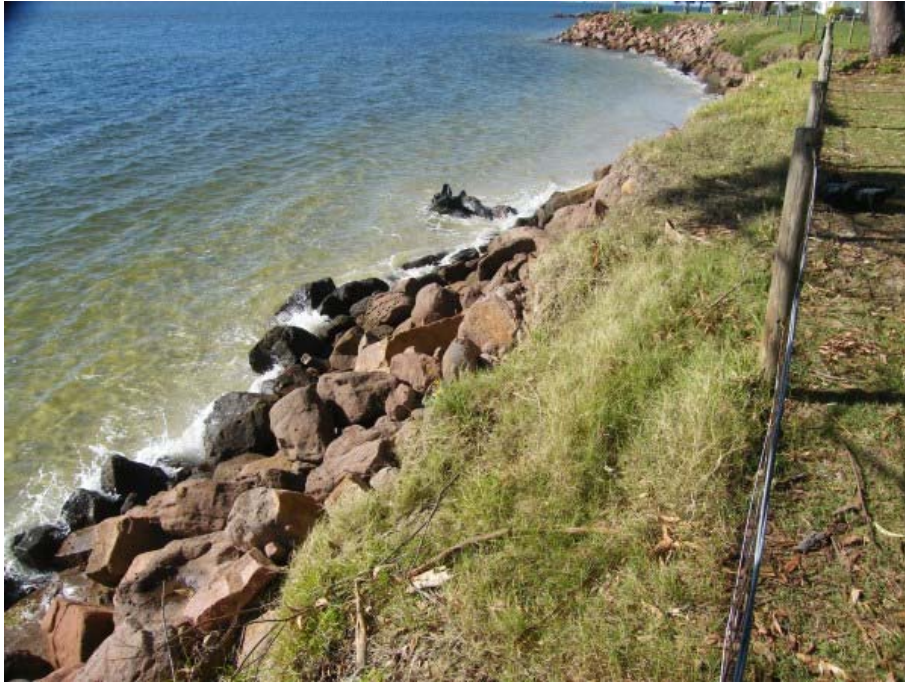
**Figure 7** Precinct 3 eastern end Conroy Park. Rock protection has been placed along this section of the foreshore to the western most groyne. *Photo Source: D Lord, 8<sup>th</sup> May 2015*

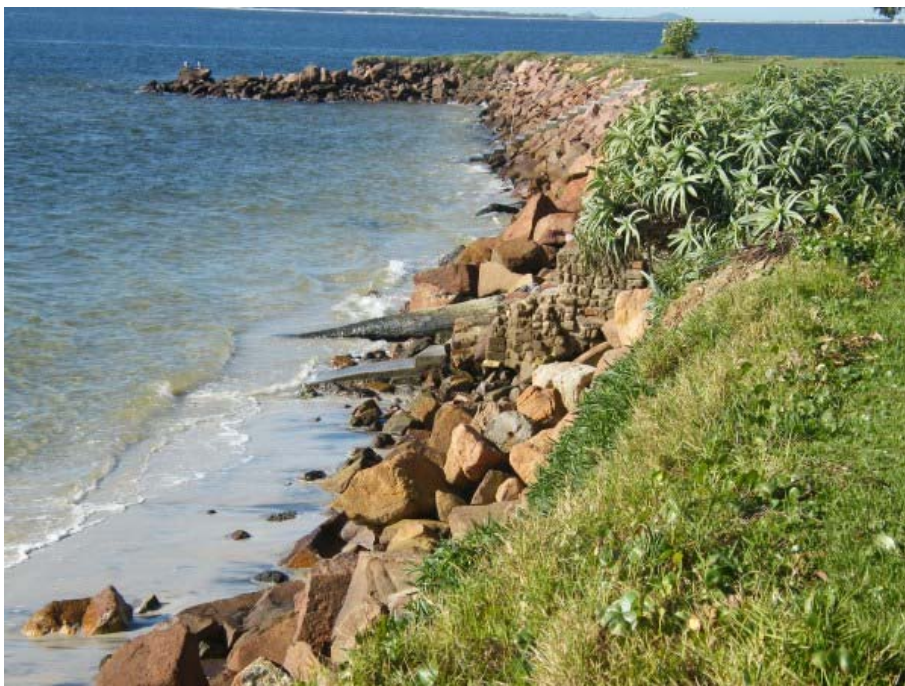
**Figure 8** Precinct 3 looking east to the western groyne. Various access stairs of differing design cross the revetment. The wall is generally steep, with some slumping and loss of armour near the crest, exposing the erodible bank behind. Armour stone size is variable. The western groyne and Port Stephens entrance are at the top of the photo. *Photo Source: D Lord, 8<sup>th</sup> May 2015*

Slumping and some overtopping of these walls are evident. Residential development along this precinct is not immediately at risk. The sandy beach has effectively been replaced by a rock wall extending into the water at most stages of the tide. Patches of sandy beach may appear at lower tides and from time to time depending on weather conditions. Upgrading of the revetment along this section should consider the reinstatement of some sandy beach amenity as appropriate.

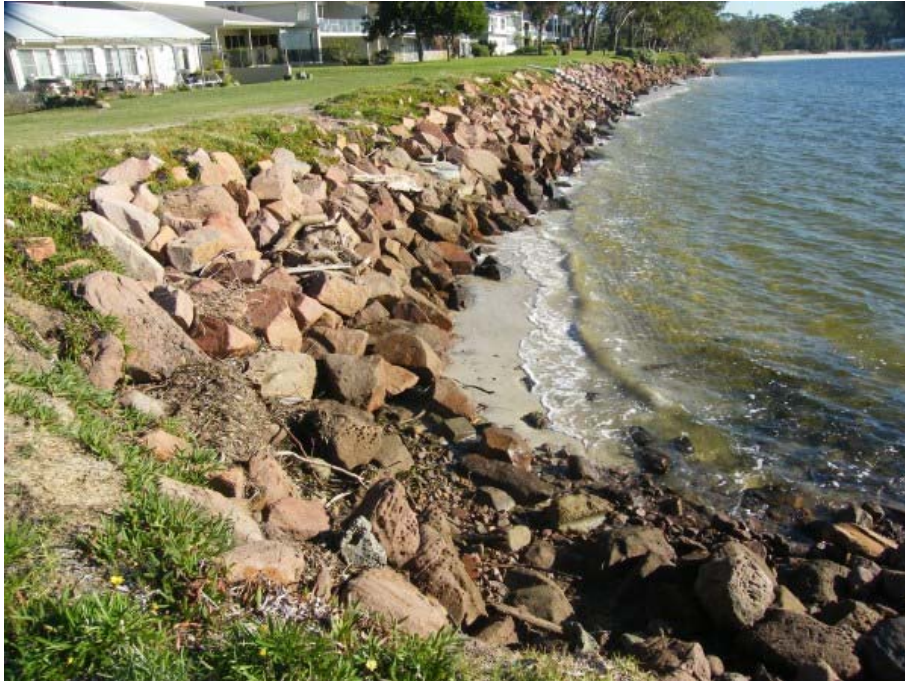
**Figure 9      Precinct 3 looking west from the western groyne to Conroy Park.**  
**Photo Source: D Lord, 8<sup>th</sup> May 2015**

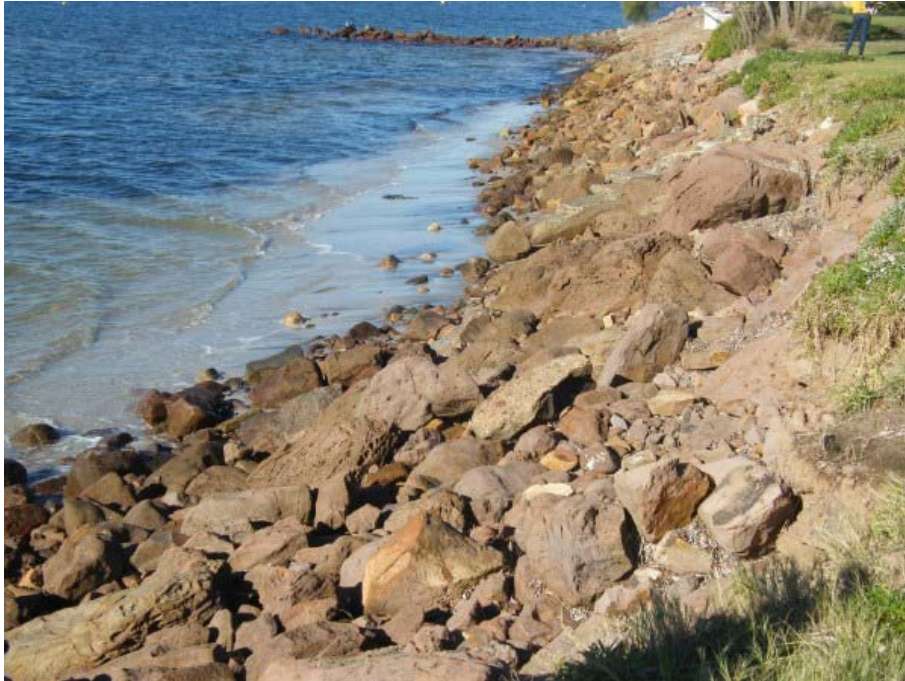
**Figure 10** Precinct 4 looking east along the revetment face from the western groyne to the next groyne east. Rock armour sizes along this section are variable with significant slumping and loss of armour near the crest, exposing the erodible bank behind. The accreted sand fillet is visible in the lower left hand corner of the photo

While this shoreline is less exposed to the ocean swells than precinct five (to the east), there is a need to reconsider the effectiveness of the existing protection which is generally undersized and failing.

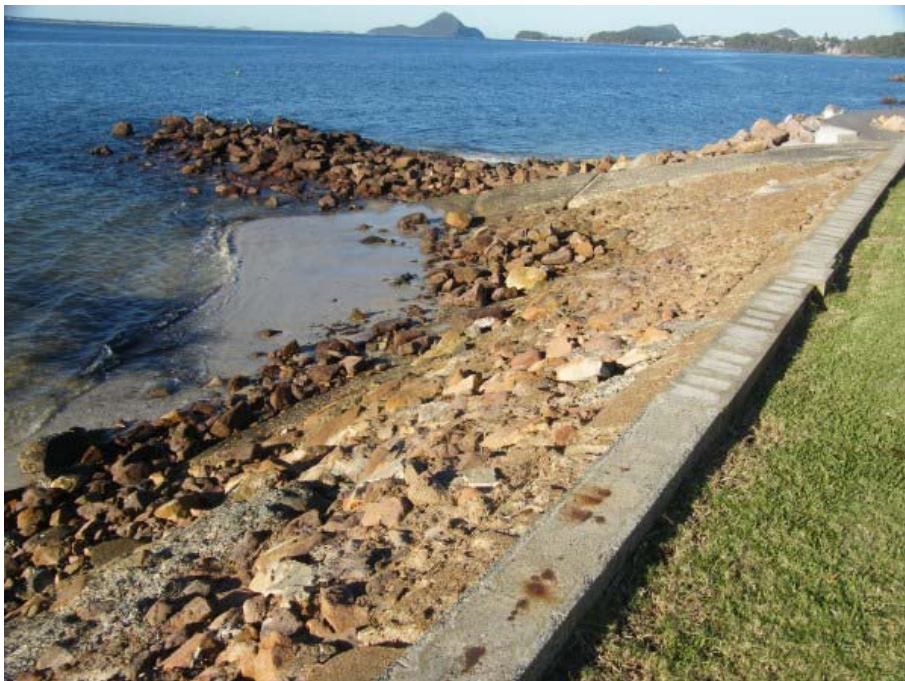
**Figure 11** Eastern end of Precinct 4. A boat ramp is located west of the groyne. Rock armour has been grouted to form a smooth wall. The rock groyne has slumped and is too short and low to anchor the beach or provide significant protection. A concrete apron can be seen beyond the groyne in Precinct 5. **Photo Source:** D Lord, 8<sup>th</sup> May 2015

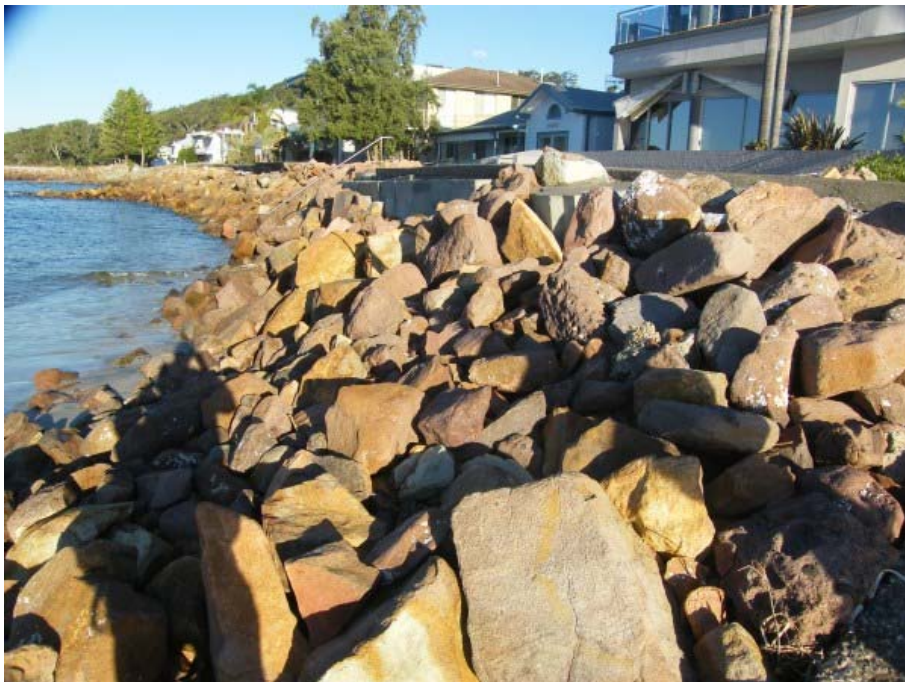
**Figure 12 Western end of Precinct 5. A vertical concrete block wall has been constructed in the centre but this precinct is predominantly tipped rock. Little or no sandy beach remains, even at low tide. The public access through Precinct 5 is compromised and wave overtopping during storms is resulting in damage and inundation of property landward of the wall.**

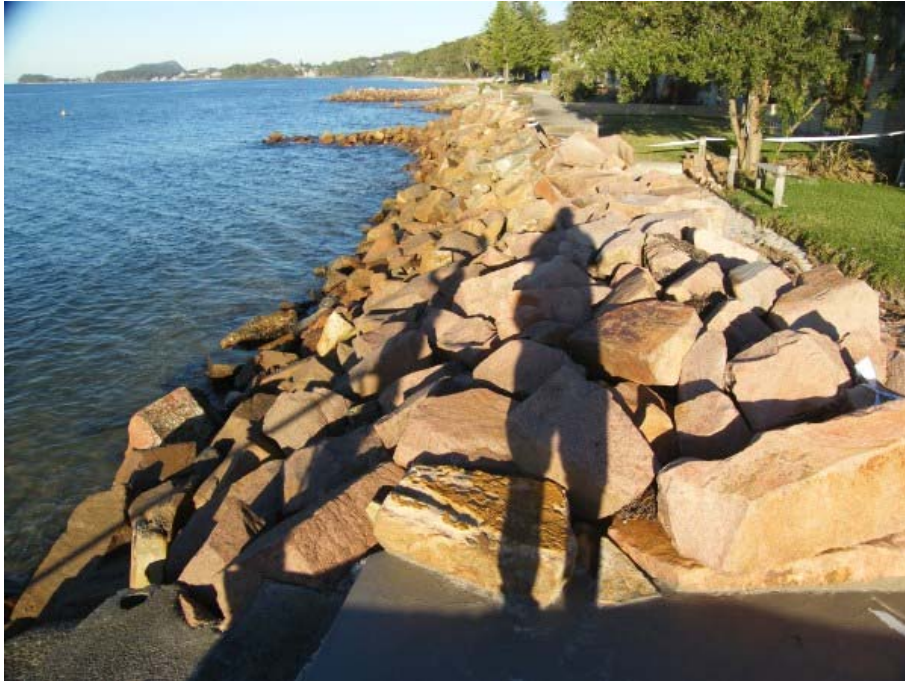
**Figure 13** Much of the rock wall along Precinct 5 comprises substantial sized stone at a flatter slope. This is the most exposed section of the study area receiving ocean swells entering the Port during storms. At the time of inspection damage to the wall including loss of armour from the face and crest was observed. Scour holes under slabs and through the wall from overtopping was evident at a number of locations. The alongshore access was closed (SES tapes) along several sections. *Photo Source: D Lord, 8<sup>th</sup> May 2015*

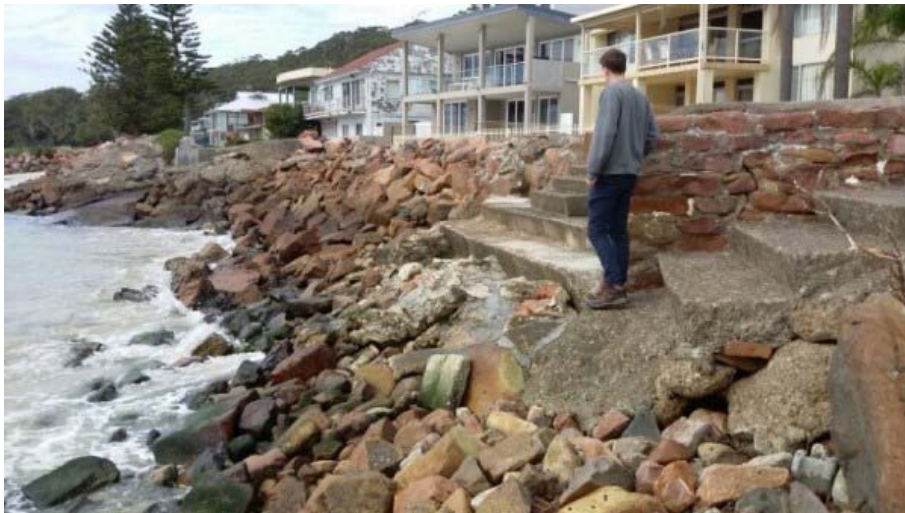
**Figure 14** Eastern end of Precinct 5. Sections of the wall have undersized armour, grouted stones and various access stairs and ramps across them. Precinct 5 is the most exposed section of the foreshore and the protection provided is poor for the level of exposure. *Photo Source: D Wainwright, 12<sup>th</sup> May 2015*

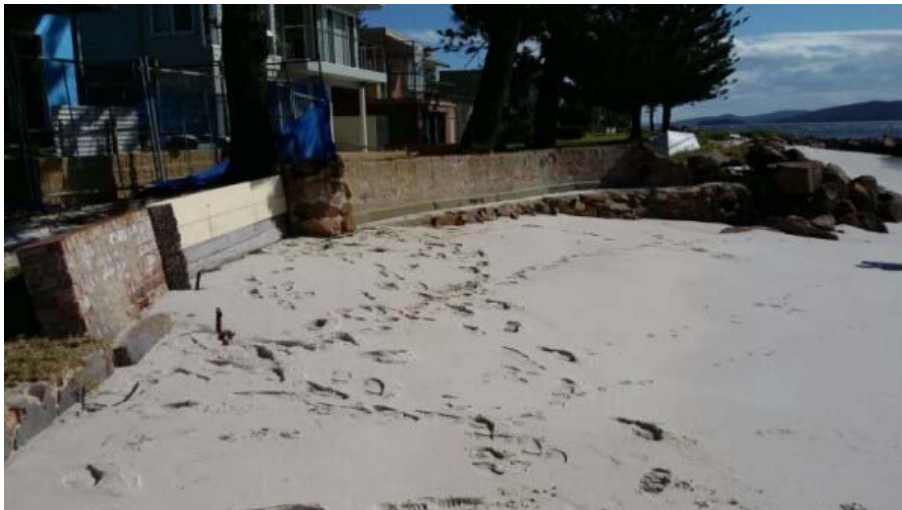
**Figure 15 Precinct 6. Located to the east of the eastern most groyne, this section just west of Bagnalls Beach is more sheltered than areas westward (Precinct 5) with generally lower protection structures and a build-up of sand on the eastern side of the groyne. The groyne was lengthened and upgraded to carry the stormwater outlet beyond the beach. The type and standard of back beach protection is variable. Overtopping is experienced right along this precinct although much of the development is set further back from the shoreline. Photo Source: D Wainwright, 12<sup>th</sup> May 2015**

Precinct 6 is more sheltered than areas to the west but is still subject to wave erosion and overtopping as evidenced by the existence of substantial sections of revetment of varying design along the foreshore. The groyne is effectively retaining sand to the east and a sandy beach area fronts the seawall along this precinct under most conditions. Even so, the presence of boat ramps along this precinct allows waves to easily run up and inundate the area behind the foreshore.

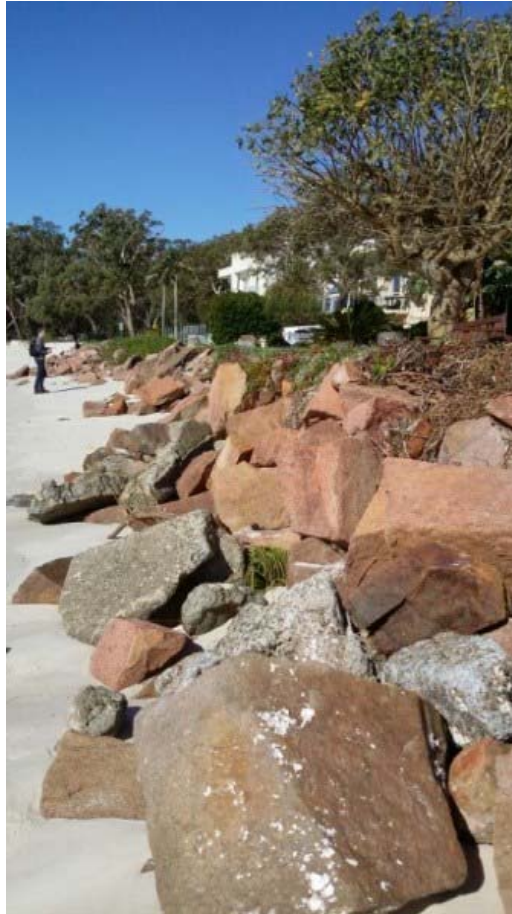
**Figure 16** Precinct 6. Some larger rock has been placed along sections of this precinct and a sandy beach remains seaward of this protection work.

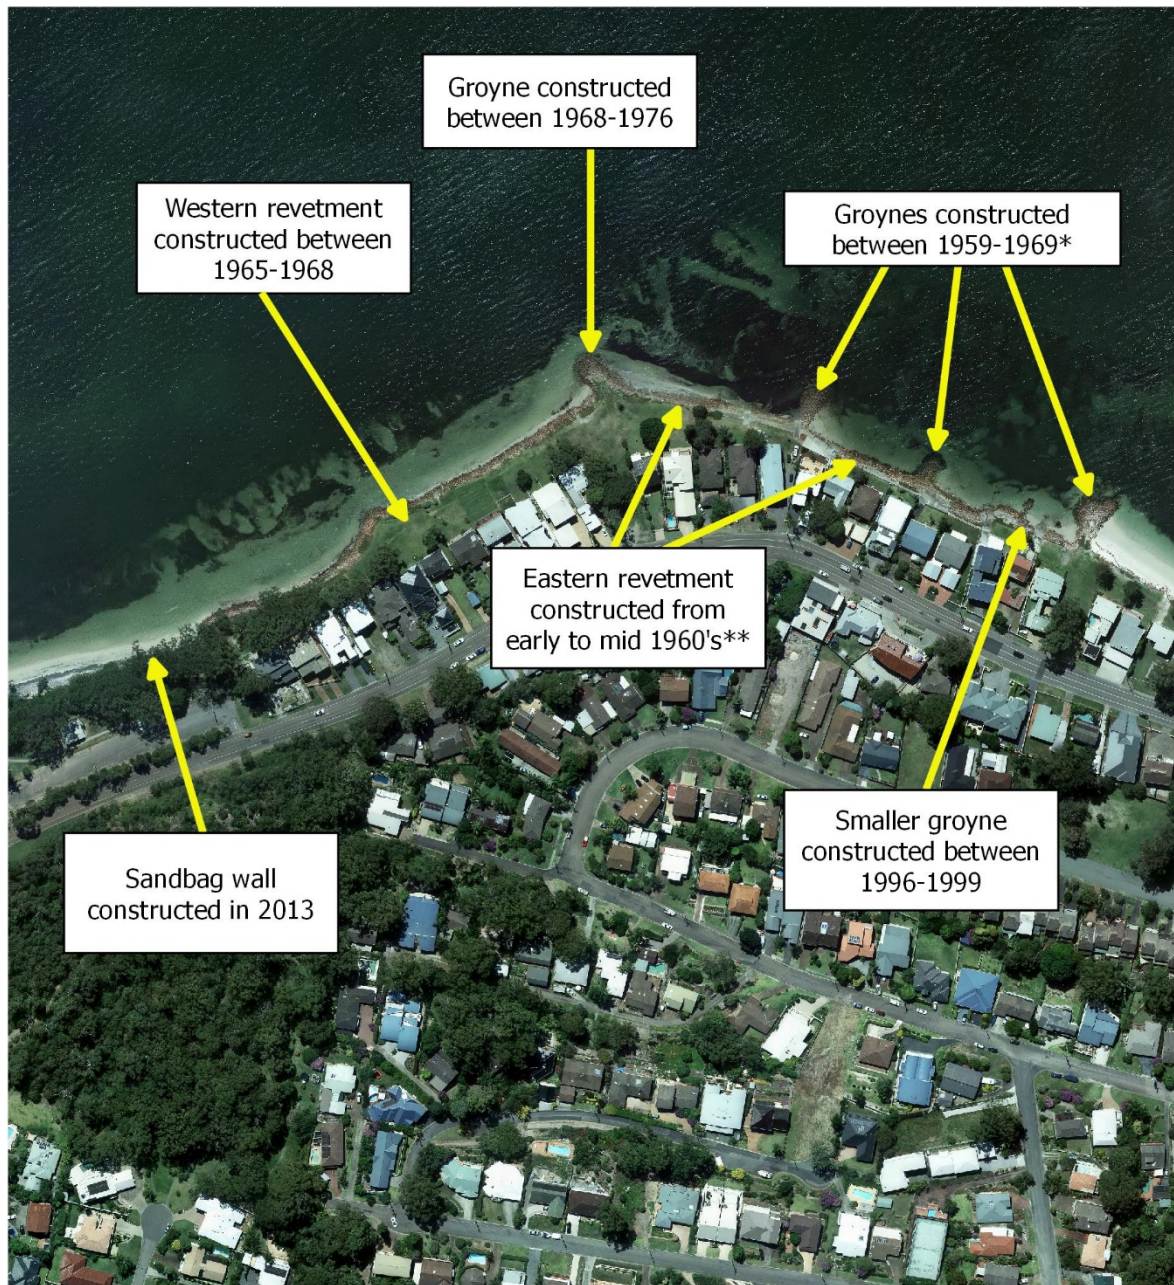
**Figure 18: Approximate Construction Dates for Foreshore Structures**

\*From shoreline alignment appears structures were here from 1963, however they become more prominent with time.  
 \*\*Progressive construction tended to be from east to west.

Figure 18 indicates the approximate dates at which different foreshore protection works have been constructed. Over time, the nature, configuration and alignment of different elements of the constructed works have changed, in response to storms or ongoing erosion. However, it is clear that there were minimal structures present during the 1950's, with the progressive construction of foreshore works occurring from the early 1960's onwards. It appears that settlement of the area during the late 1940's and 1950's, following subdivision in 1945 occurred when the beach was particularly wide as a result of a pulse of sand moving from east to west around Sandy Point. However, in the late 1950's through to the 1970's, coastal storms resulted in a dramatic re-alignment of the shoreline around Sandy Point, as sand which was present in large lobes offshore of the site were progressively moved in a westerly direction, leaving the shoreline relatively denuded of sand and with a comparatively narrower beach.

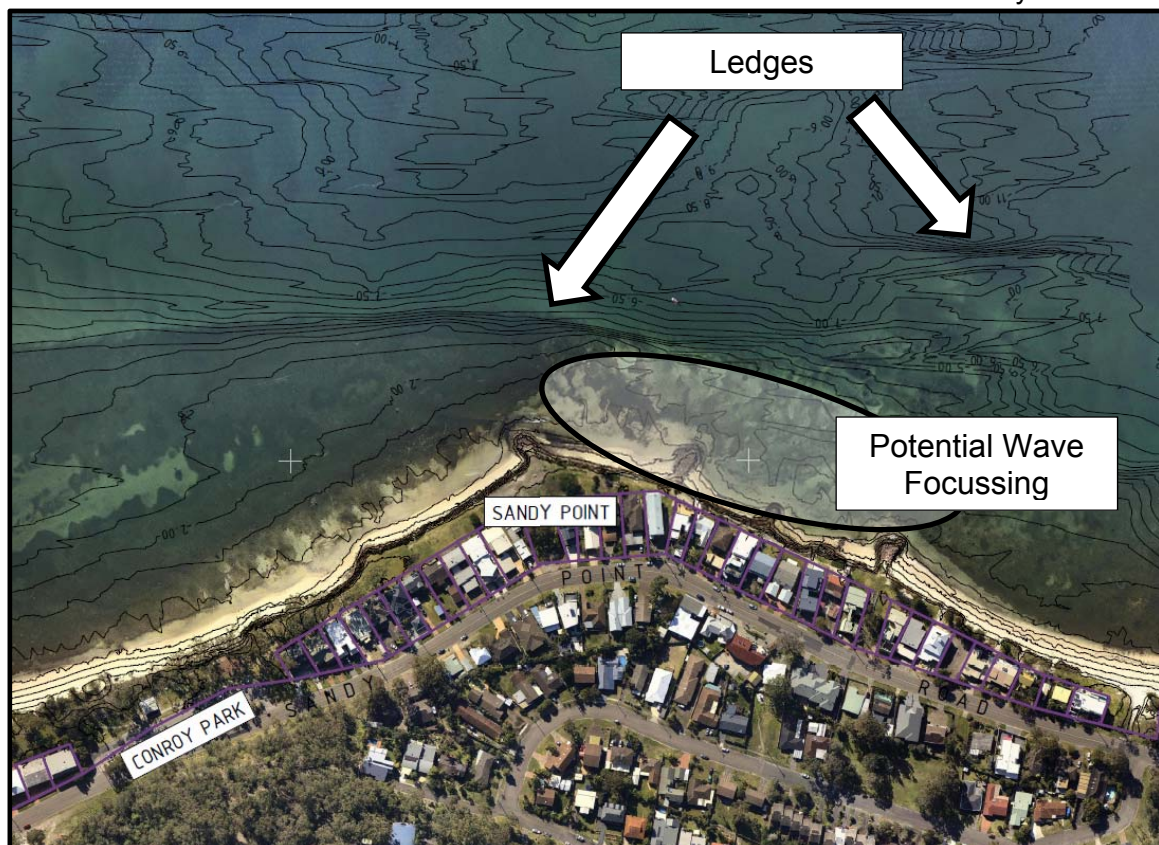
**Figure 20 Extract from 2015 Survey Offshore of Sandy Point**

Based on the 2015 hydrosurvey (Figure 20), bed elevations offshore of the site vary from 0 at the shoreline, down to elevations of around -10.0m AHD some 400 – 500 metres offshore of the site. The nearshore variation of elevation changes has a different character on the east and western sides of Sandy Point.

Offshore from the eastern side of Sandy Point the bathymetry contains a number of ledges and drop overs which effect steep localised falls of 3-5 metres in the bathymetry. Based on the patterns of seagrass present in these areas, it appears likely that these features cause localised wave focussing and scouring of seagrasses to the east of Sandy Point. Conversely, to the west of Sandy Point, seagrass patches are denser and broader. This appears to result from Sandy Point providing a sheltering

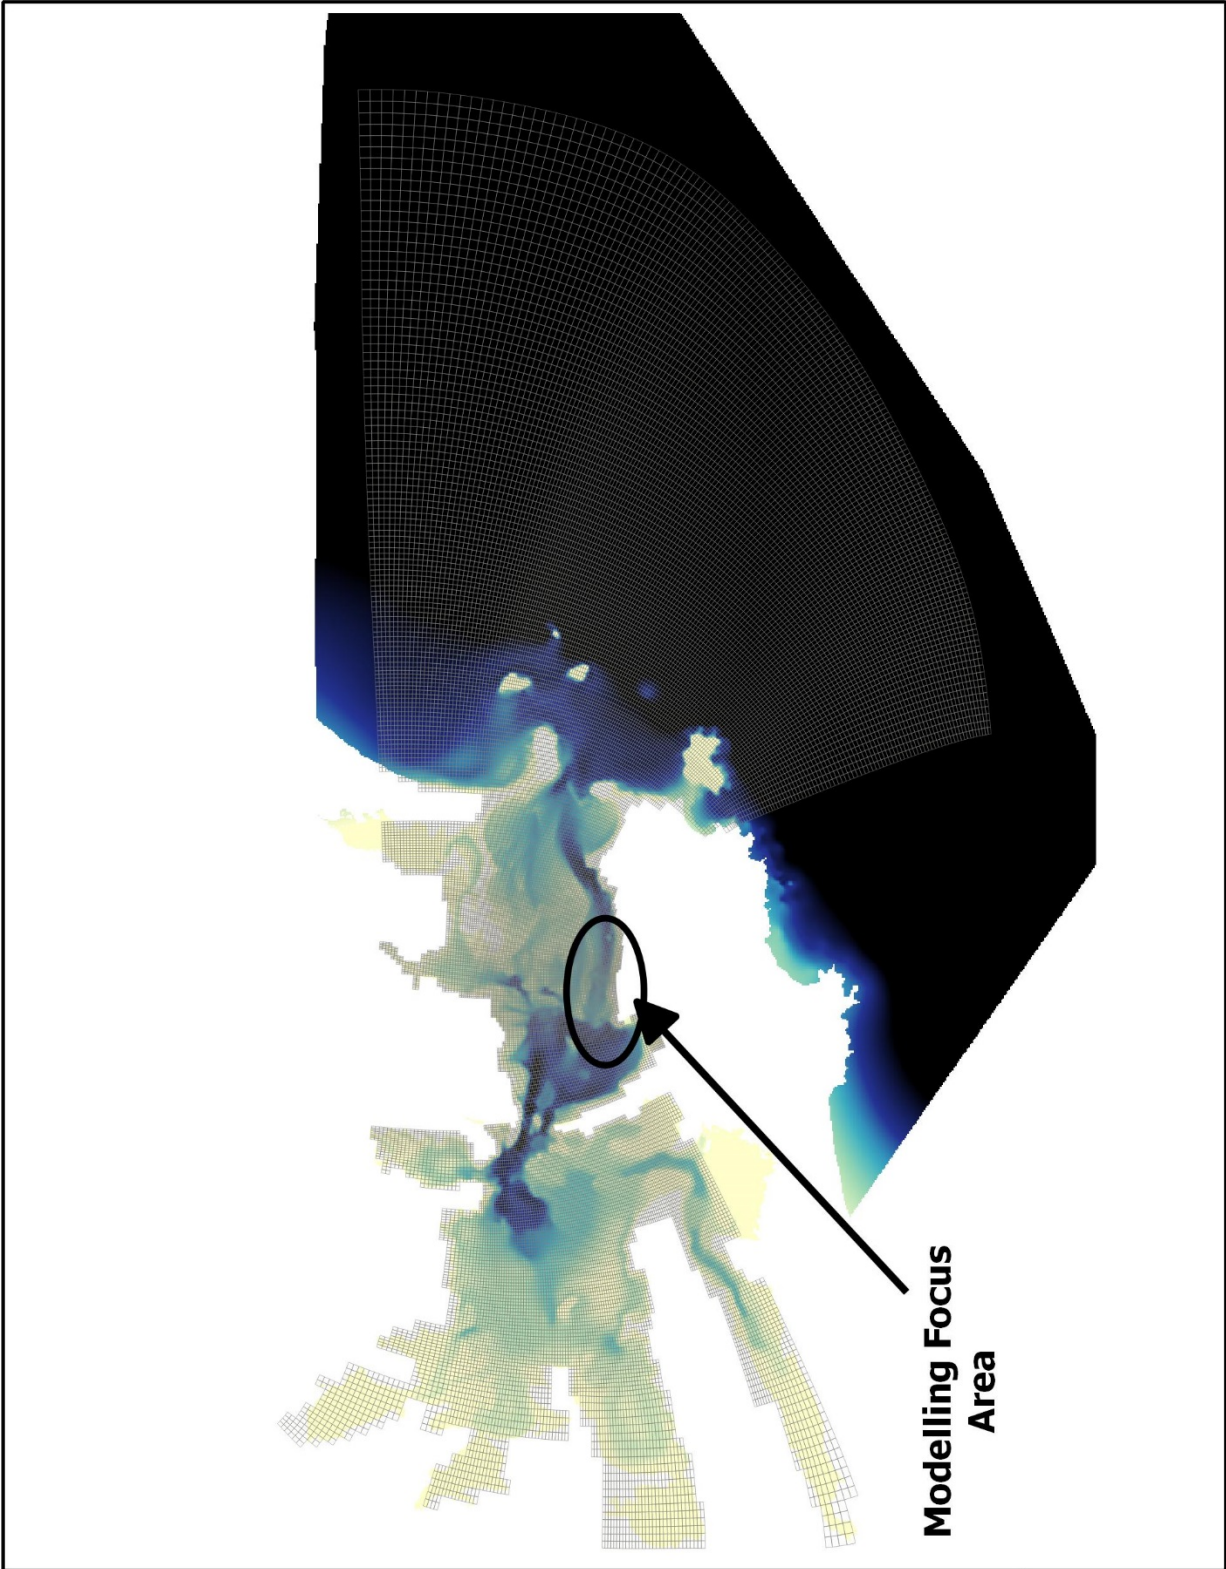
<b>Figure 24: Model Extent and Configuration</b>

The model built for this project extends over the entire surface of Port Stephens, and extends into the ocean to the 100m contour Figure 24. At this depth, it is reasonable to input waves as measured by the wave recorder network maintained offshore of NSW. The model covers large portions of the tributaries of Port Stephens, including Tilligerry Creek and the lower reaches of the Lower Myall and Karuah Rivers, although those areas are not targeted specifically for analysis at this time and the resolution there is less than around the study area. The model could be readily adapted for other locations in the future.

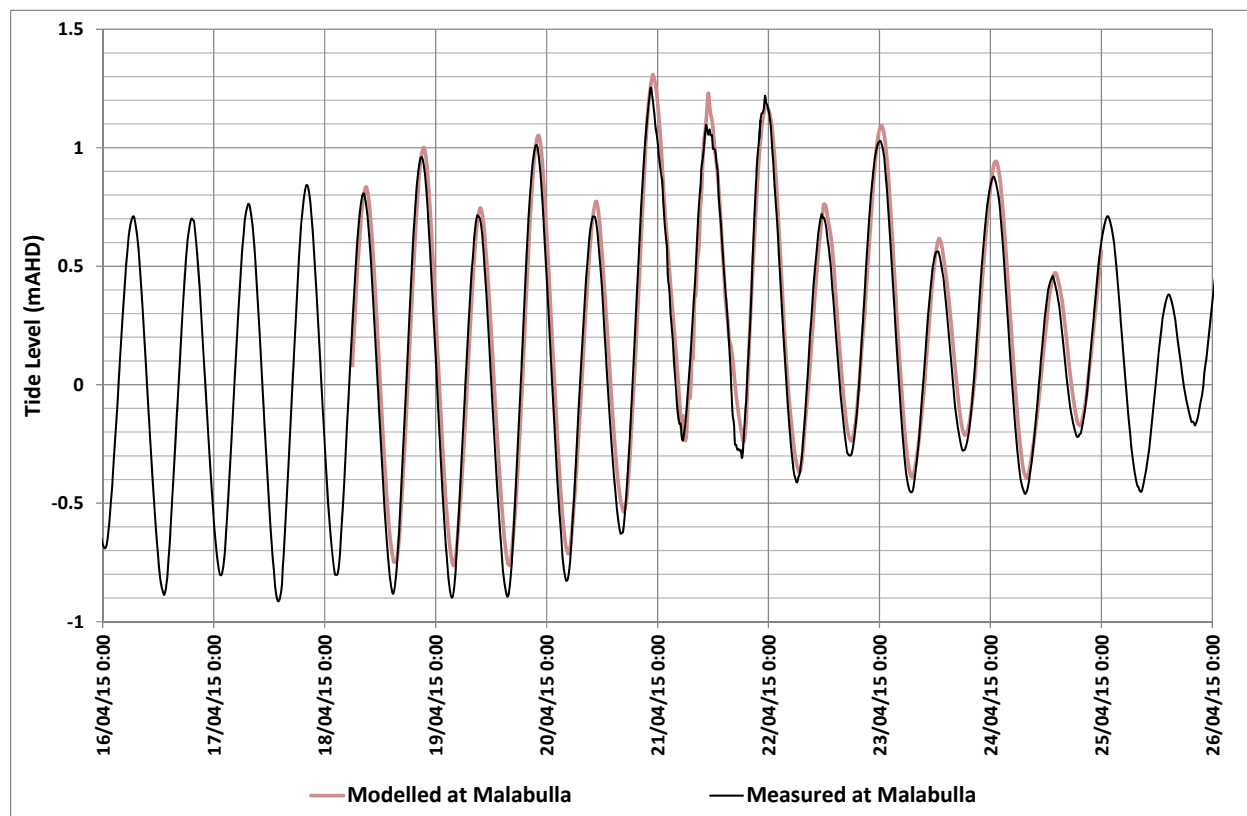
**Figure 26 Modelled and Measured Tides at Mallabula Gauge, April 2015 Storm**

A time step of 0.05 minutes was adopted to achieve stability. A comparison of the resulting modelled and measured tide levels at the Mallabula gauge site is provided in Figure 26 covering a range of tidal cycles over 9 days.

Even so, the performance of the model is reasonable for storm conditions, considering the purpose to which it is to be applied in this study (deriving design conditions for conceptual design). Future users of the model would need to judge the sufficiency of the model for their particular purpose before application.

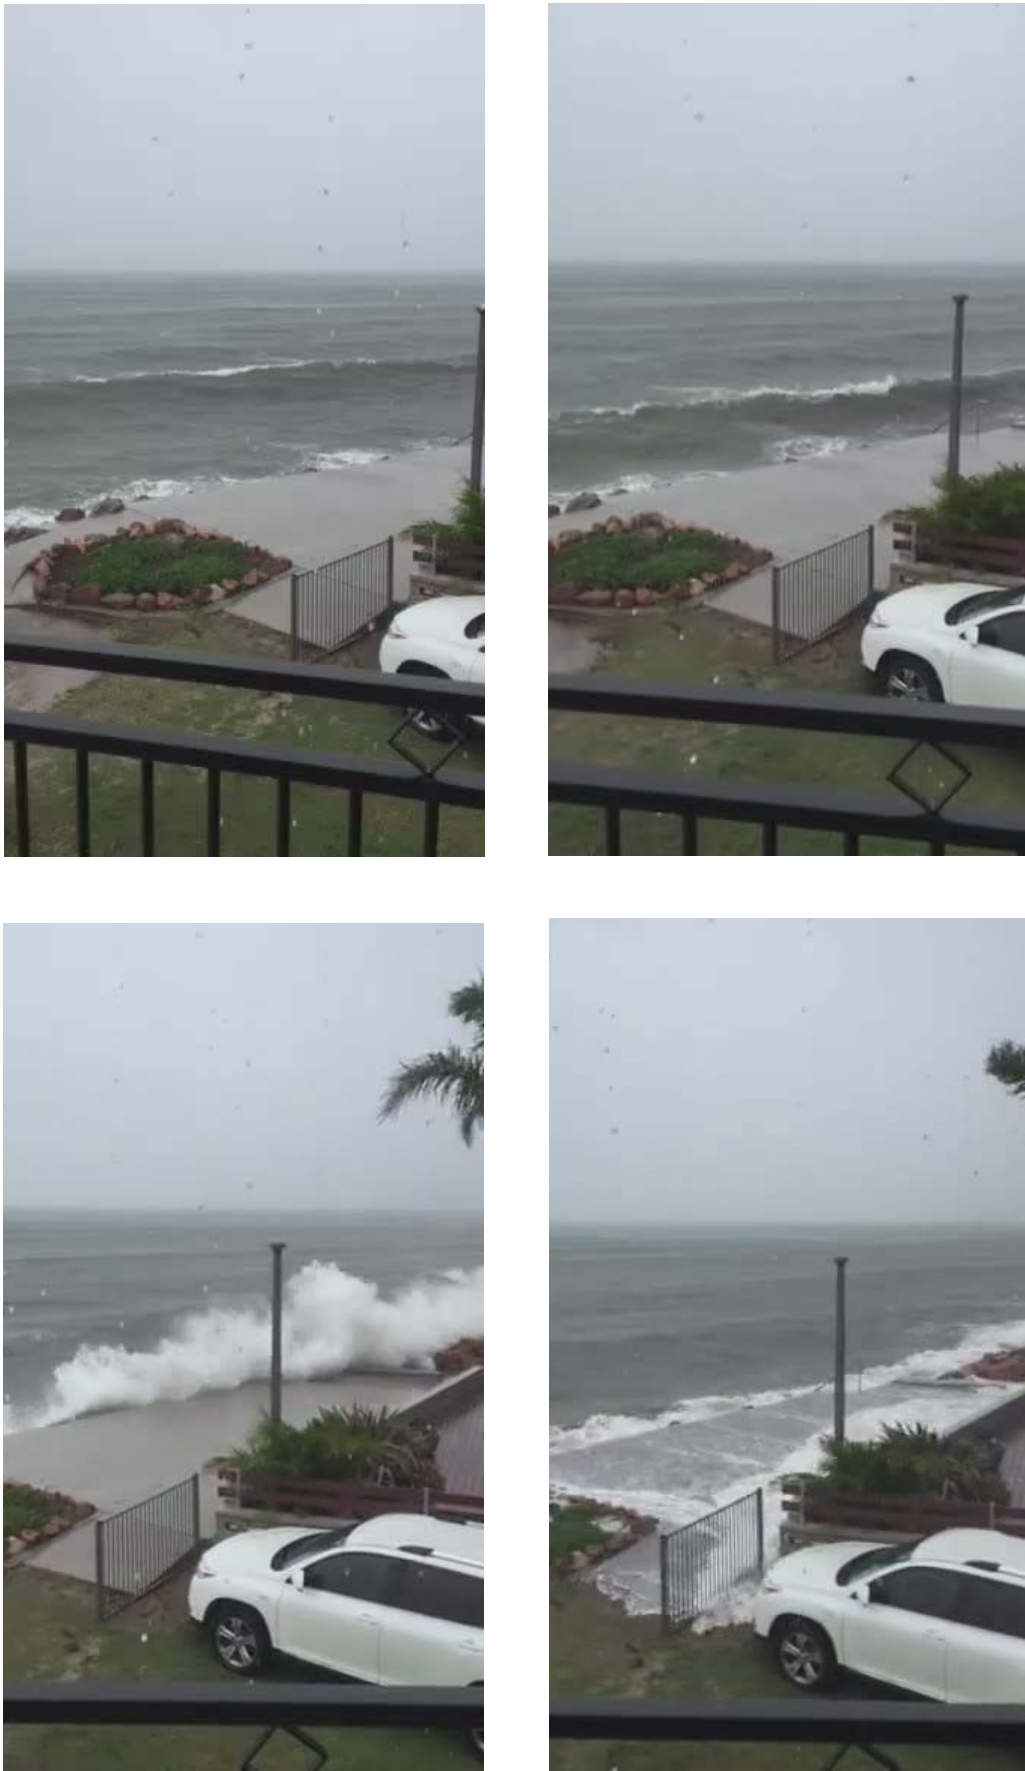
**Figure 27** Stills from Video of Foreshore Overtopping, 21<sup>st</sup> April, 2015.  
(Top Left: Approaching, Top Right: Breaking, Bottom Left: Impact, Bottom Right: Backwash)

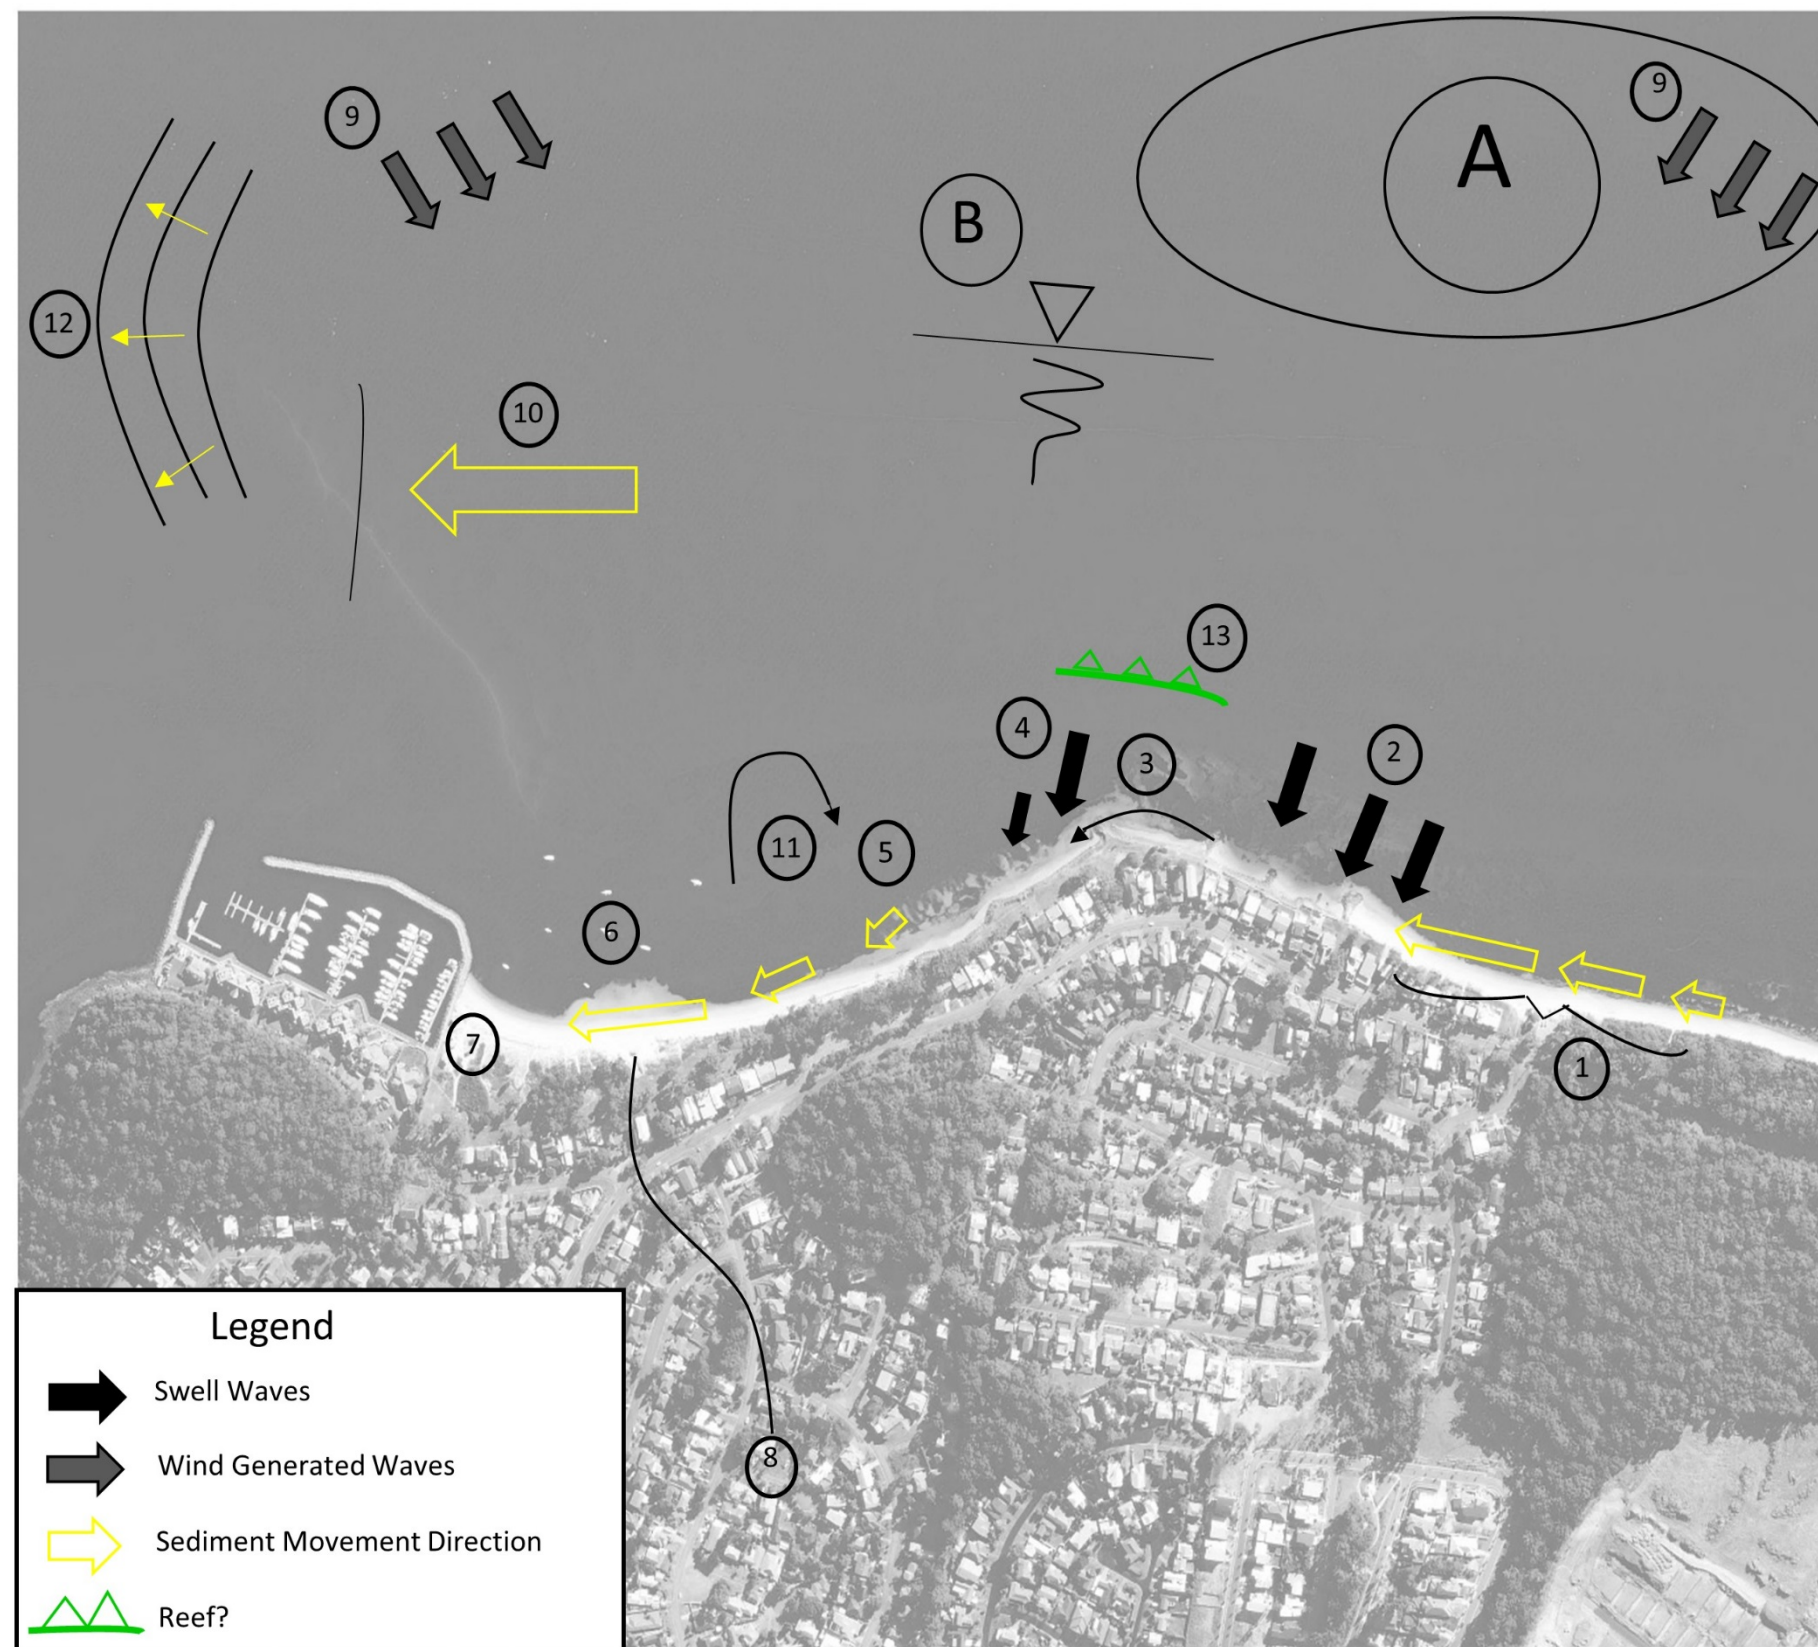
A conceptual model summarising the coastal processes surrounding the site has been prepared. This model is presented as Figure 33

- A. Long Term changes to the Flood Tide Delta of Port Stephens cause ongoing change to wave refraction and current patterns. These affect patterns of erosion and deposition within the study area.
