## **Appendix A      Coastal Processes Study**

## **Sandy Point/Conroy Park Coastal Process Study**

Prepared for Port Stephens Council

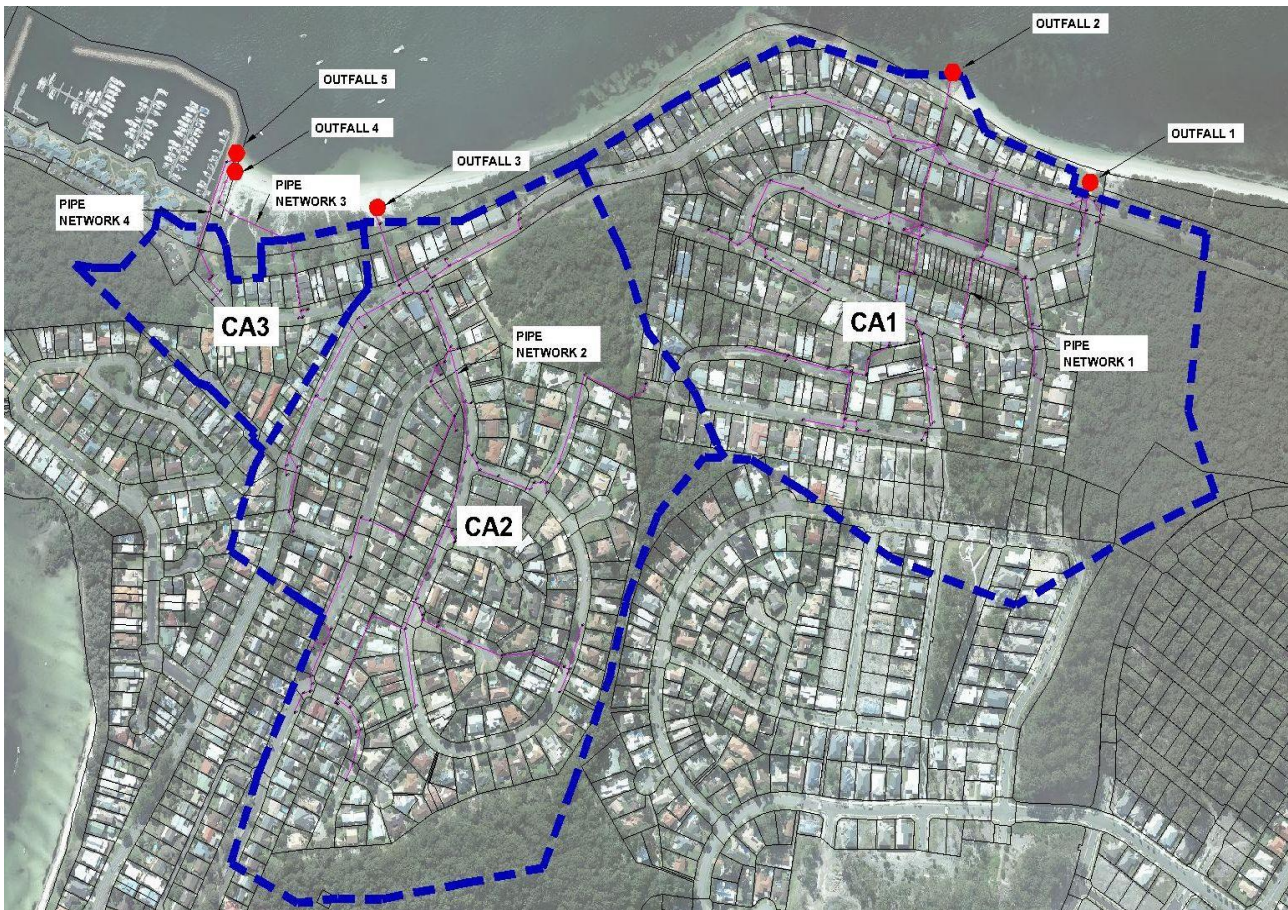
Figure 1 - Site Location & Catchment Plan

The study area is located within the township of Corlette (Figure 1). Corlette is located along the southern foreshore of Port Stephens. The terrain within the catchments of the study area ranges from moderately to very steep, but the foreshore area itself is almost flat.

The study area contains three main catchments areas (Figure 1) that are described as follows:

There are five main stormwater discharge locations located within the study area. These are shown on Figure 1 as Outfalls 1 to 5. A description of each is given below.

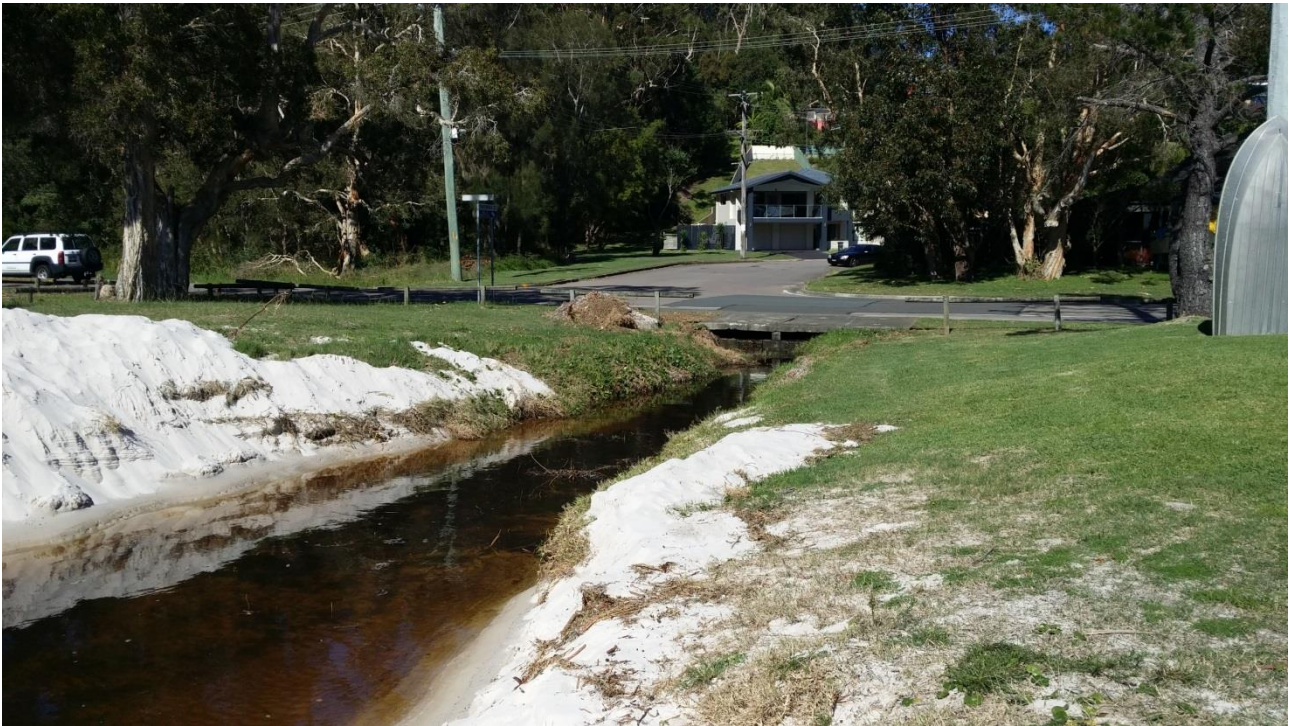
Photo 1 - Looking south towards surcharge pit at Outfall 1 location.

Outfall 1 is located within catchment CA1. It consists of a surcharge pit and overland flow path across the beach reserve (Photo 1). It is located at a lowpoint within Sandy Point Road and serves as a relief point during localised flooding of Sandy Point Road during large storm events. The surcharge path requires regular maintenance for it to work effectively and it had recently been cleaned out prior to our inspection.

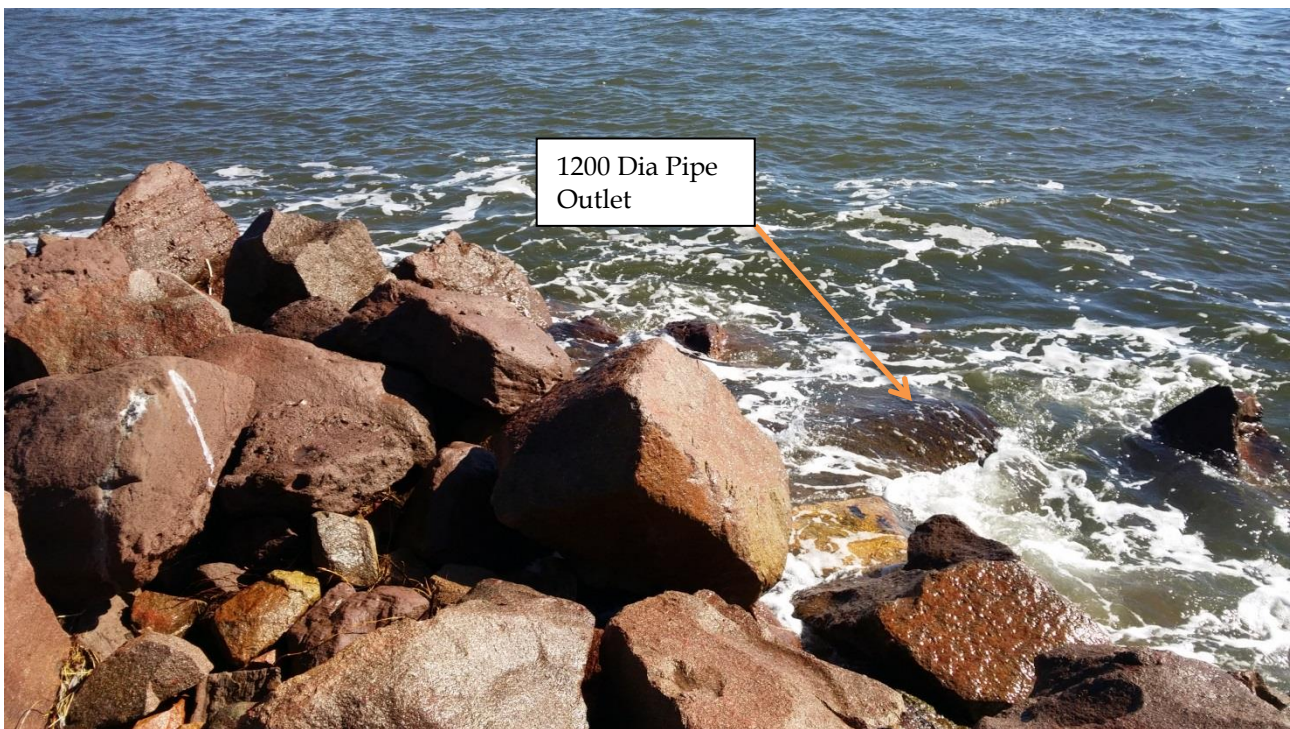
Photo 2 - Outfall 2 Looking north

This is a major discharge point located within catchment CA1. It consists of two, 1200mm diameter reinforced concrete pipes under a rock groyne wall (Photo 2).

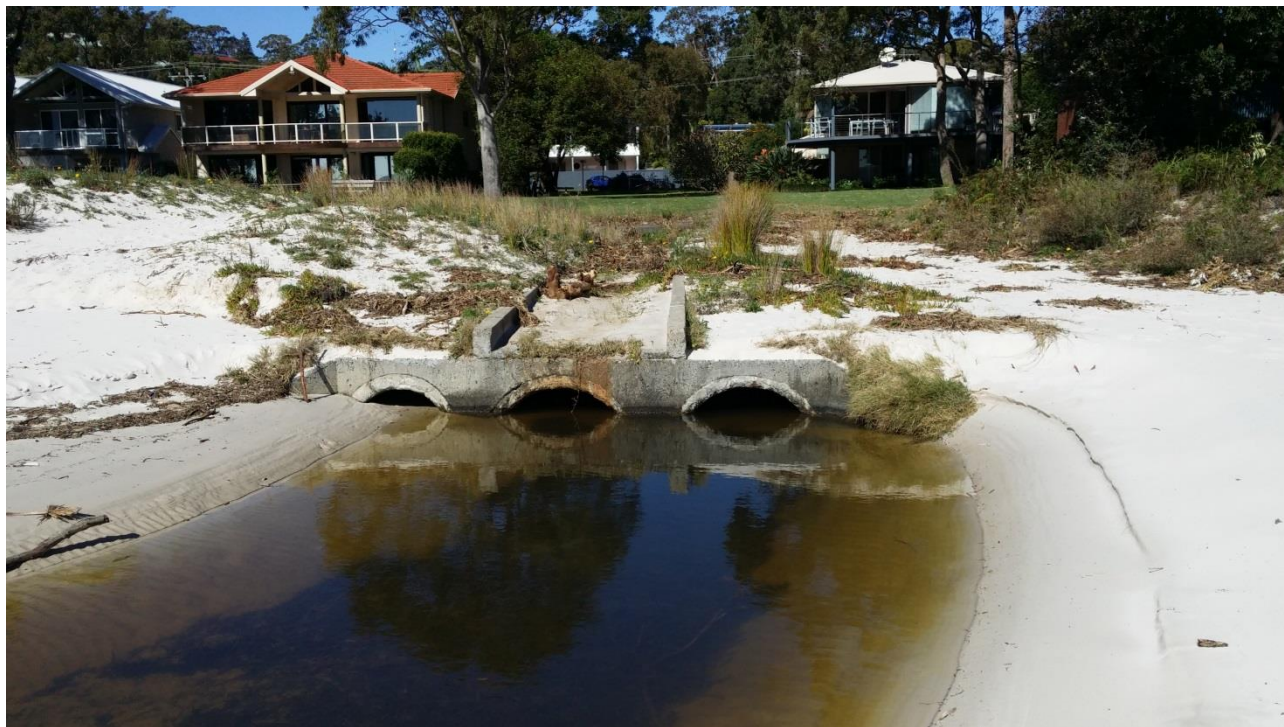
Photo 3 - Outfall 3 Looking South East

Outfall 3 is located within catchment CA2. It is a major discharge point consisting of three 1200mm diameter concrete pipes discharging directly onto Corlette Beach (Photo 3). The pit immediately upstream of the outlet contains a surcharge outlet, surcharging larger flows during major storms into an existing concrete apron.

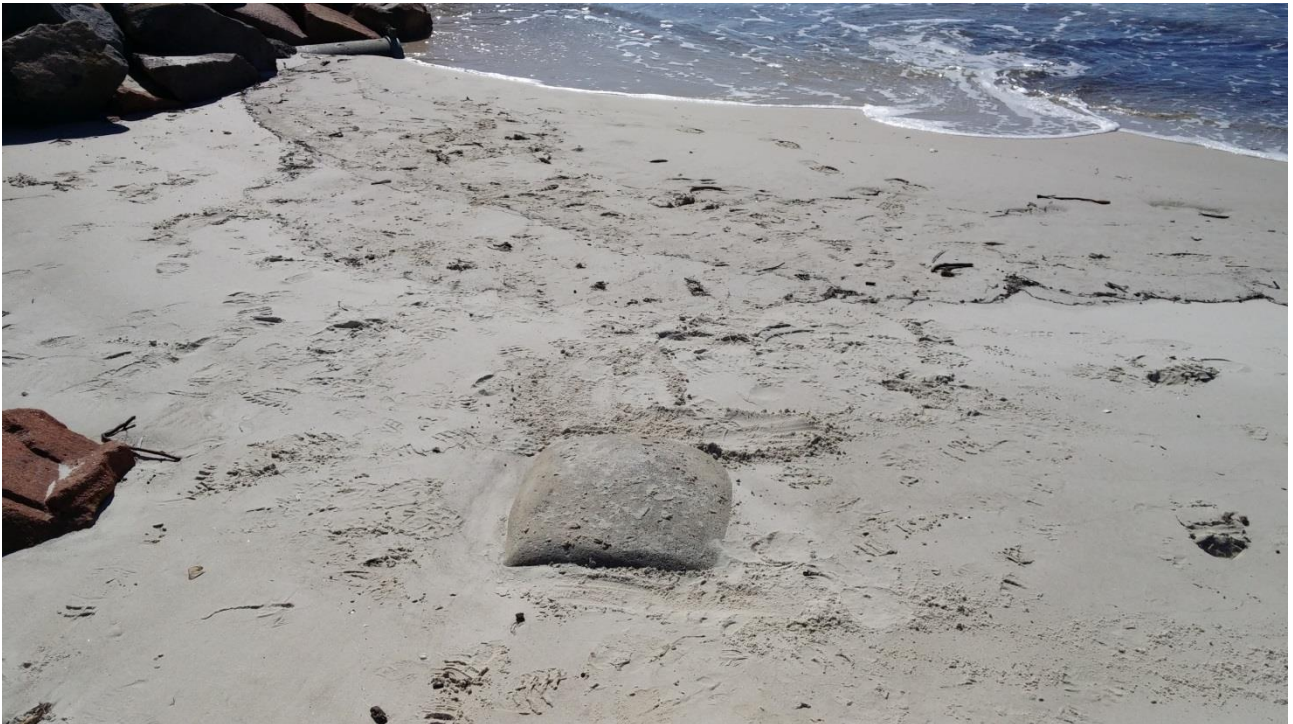
Photo 4 - Outfall 4, completely blocked.

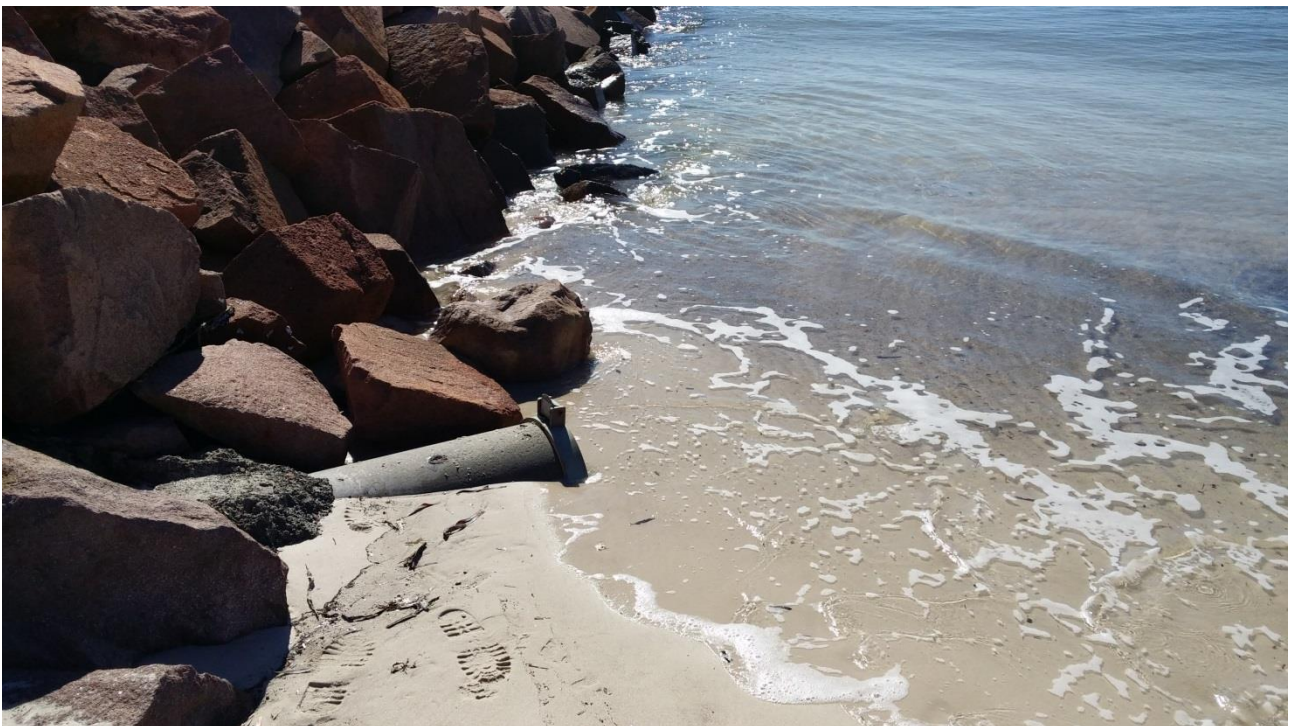
Photo 5 - Outfall 5, partially blocked with flap valve removed.

Outfall 5 is a 375mm reinforced concrete pipe located under the eastern breakwater of the marina. This was partial blocked during our site inspection (Photo 5) and was missing a flap valve.

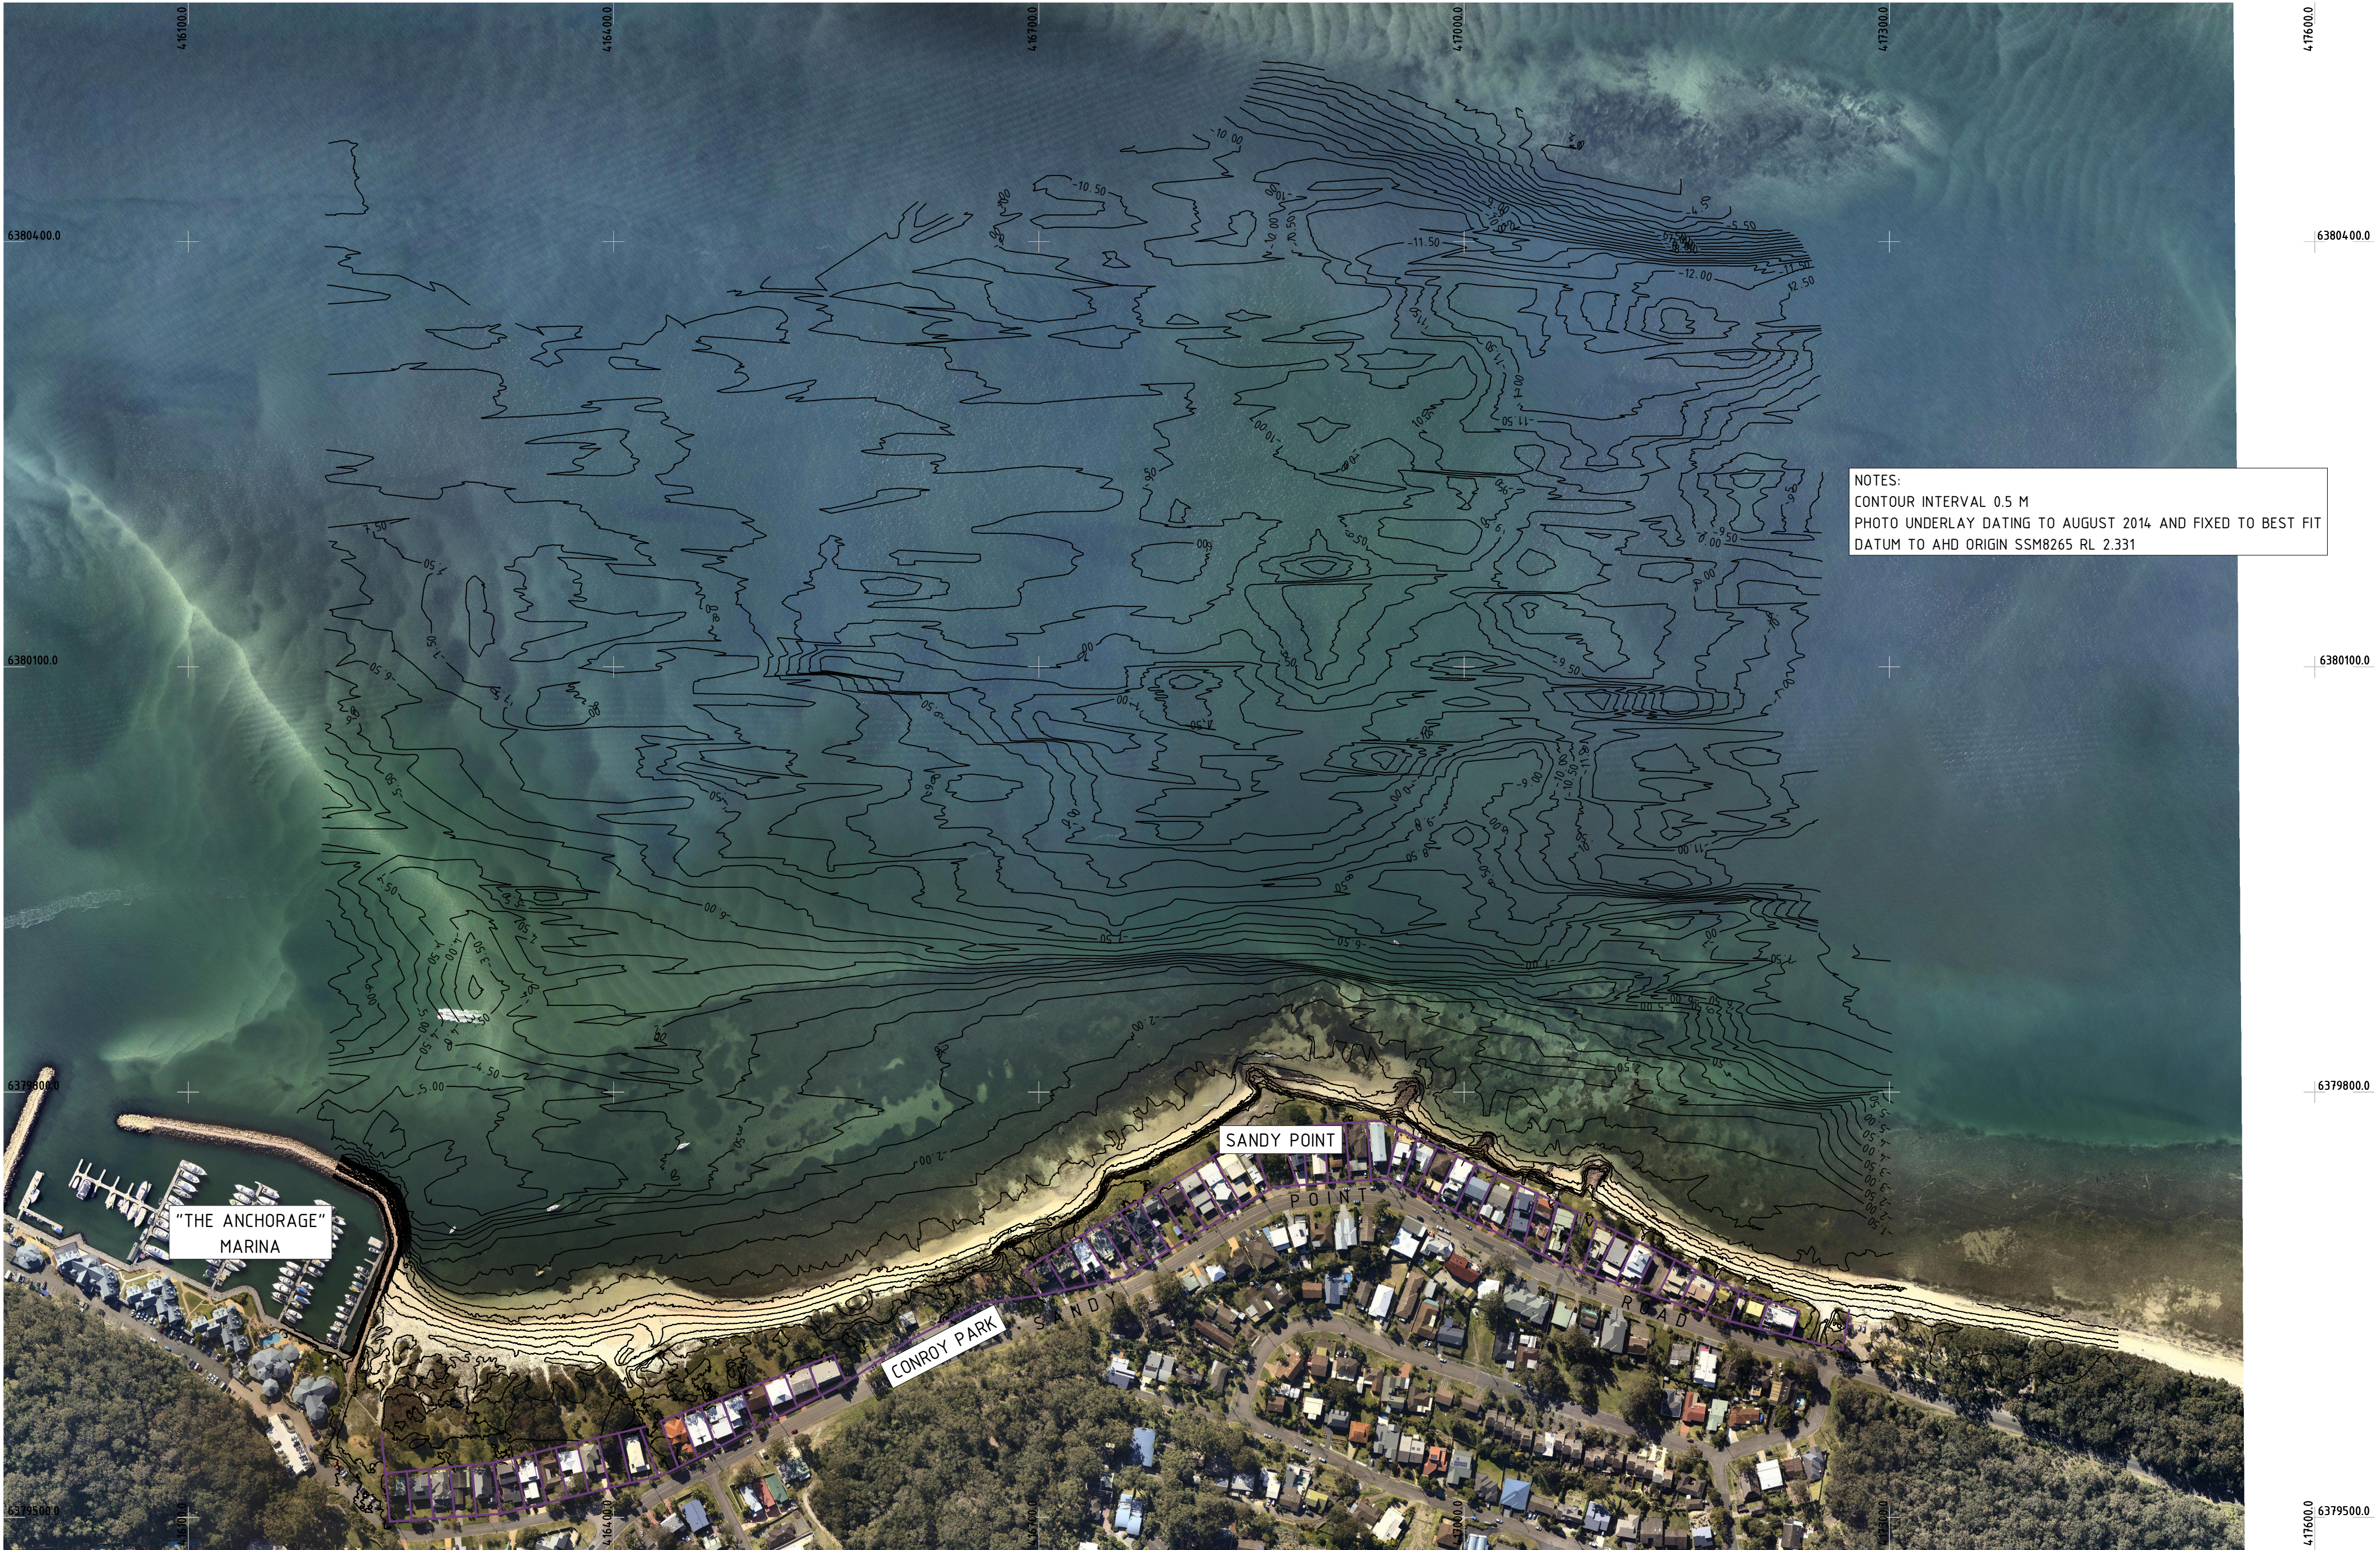
NOTES:  
CONTOUR INTERVAL 0.5 M  
PHOTO UNDERLAY DATING TO AUGUST 2014 AND FIXED TO BEST FIT  
DATUM TO AHD ORIGIN SSM8265 RL 2.331

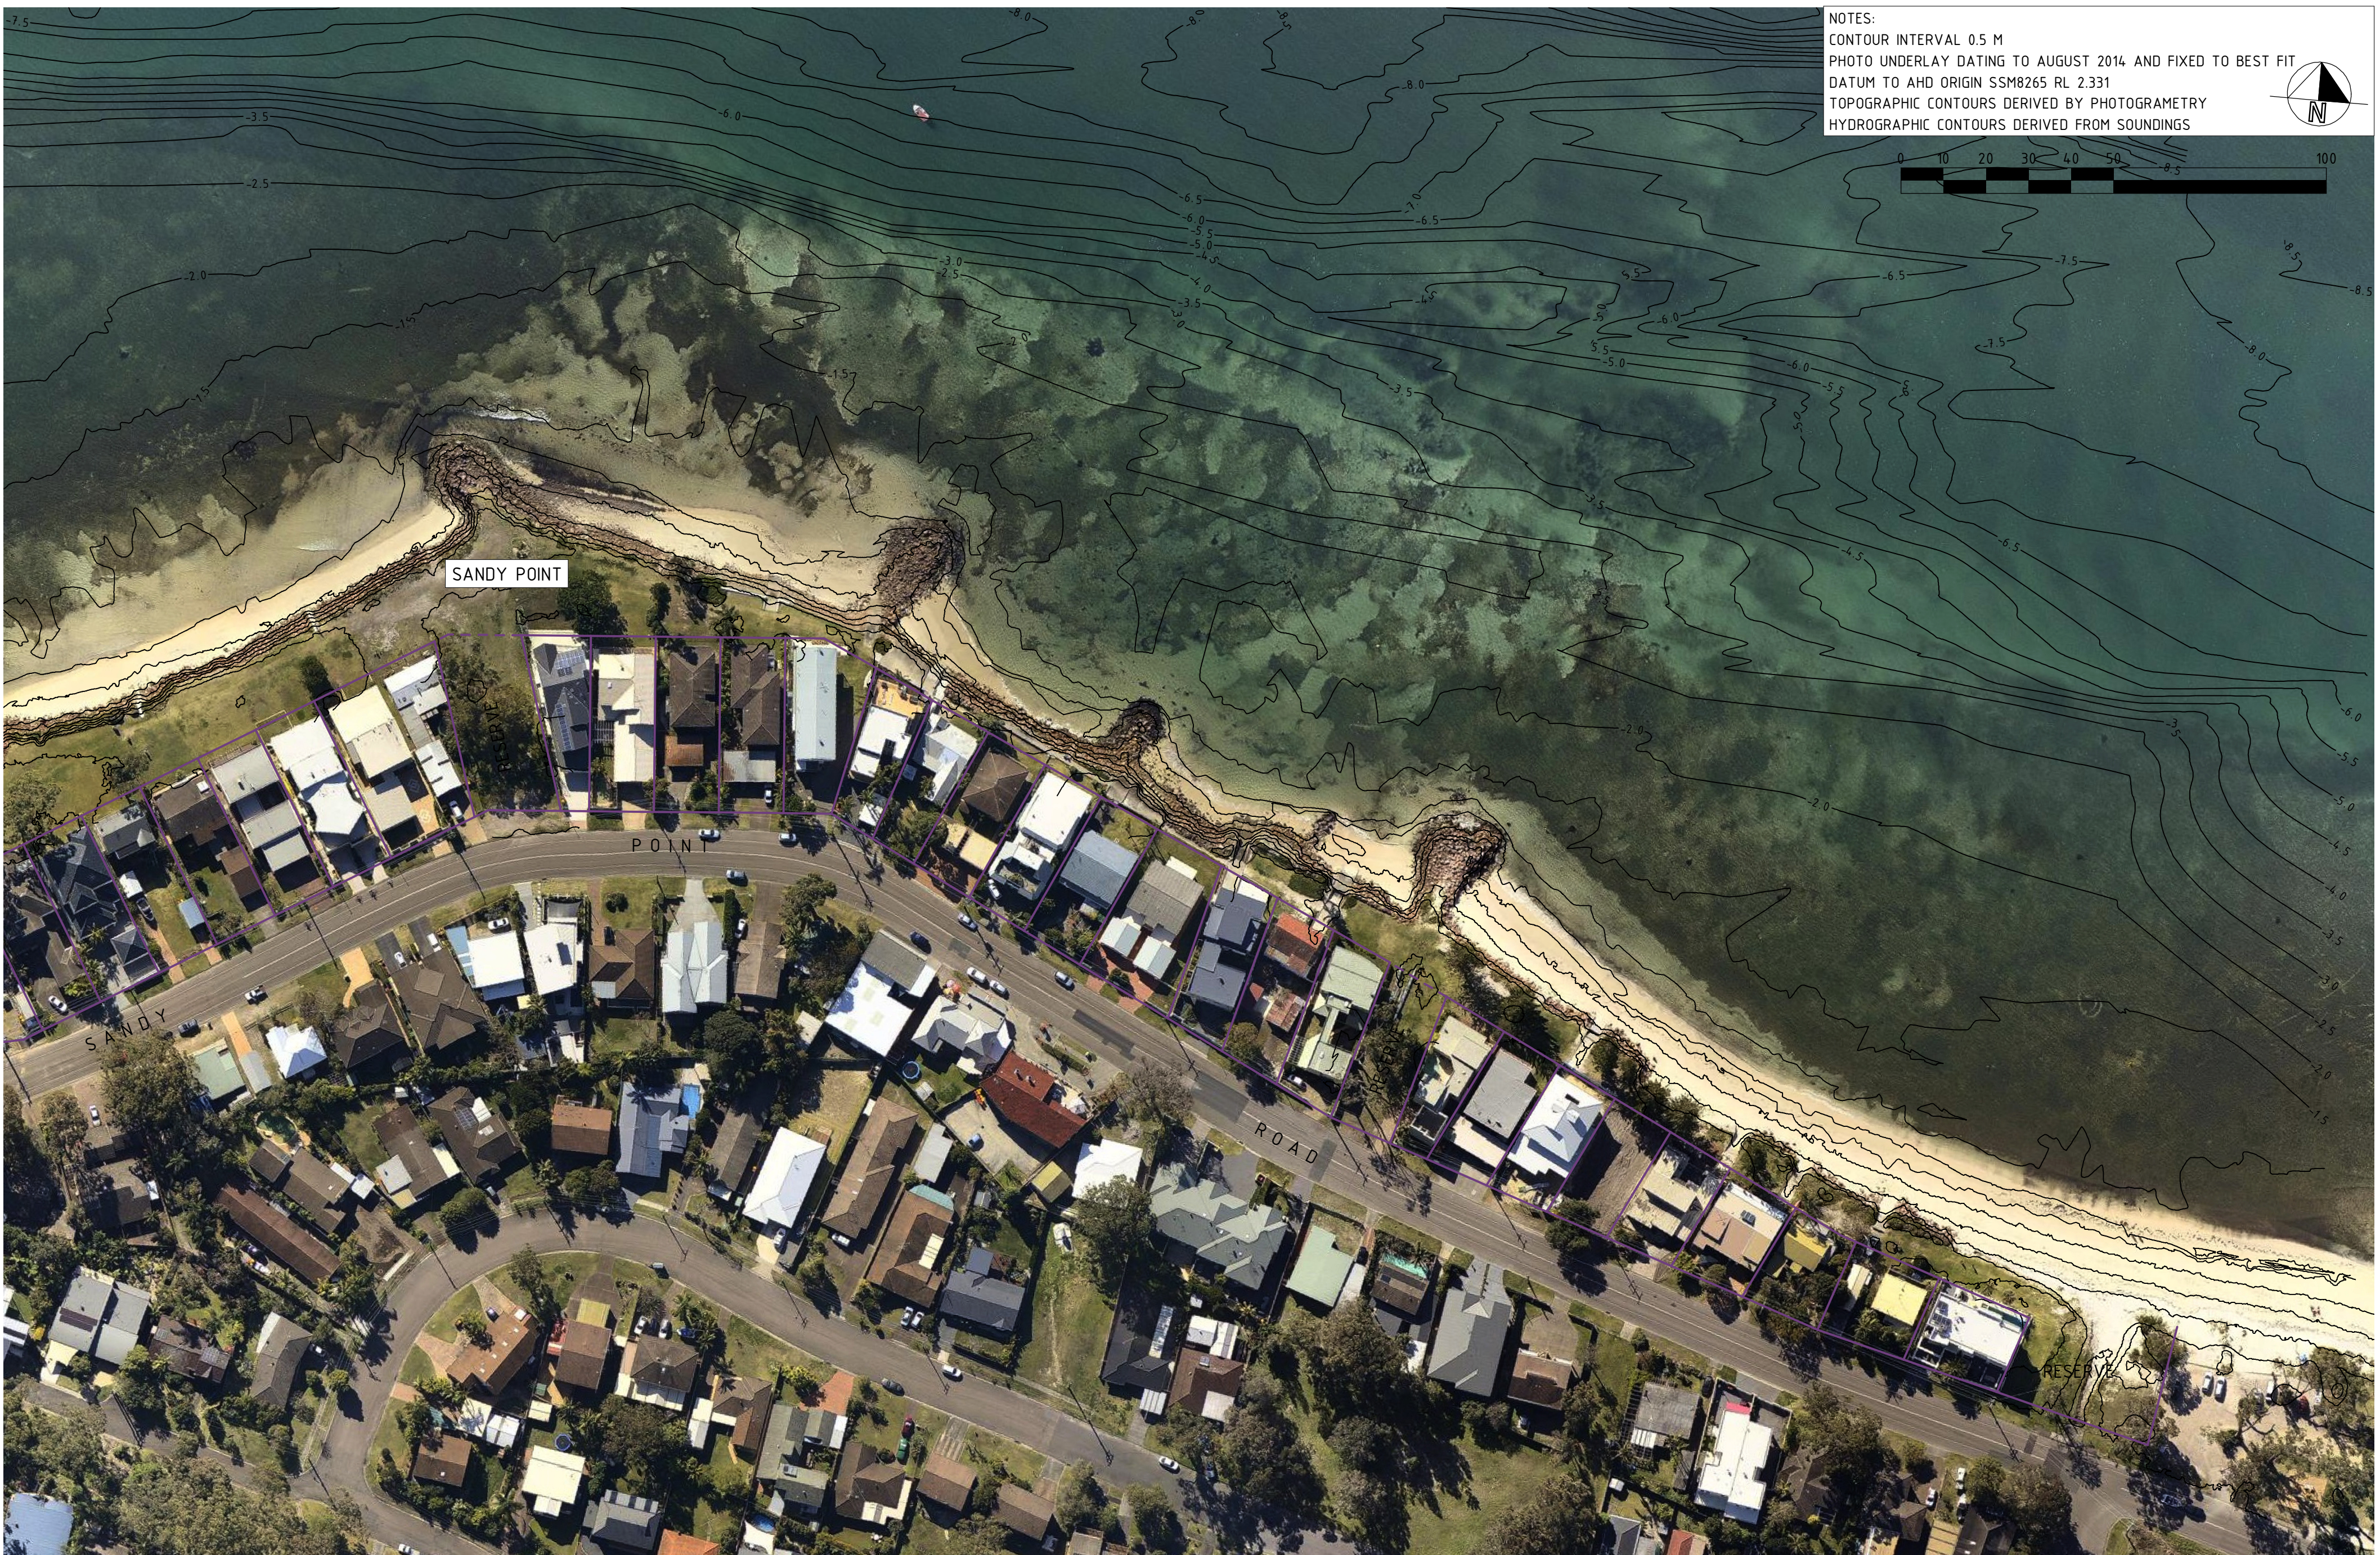
NOTES:  
CONTOUR INTERVAL 0.5 M  
PHOTO UNDERLAY DATING TO AUGUST 2014 AND FIXED TO BEST FIT  
DATUM TO AHD ORIGIN SSM8265 RL 2.331  
TOPOGRAPHIC CONTOURS DERIVED BY PHOTOGRAMETRY  
HYDROGRAPHIC CONTOURS DERIVED FROM SOUNDINGS
