**Hunter Estuary
Processes Study**

**Report MHL1095
November 2003**

**NSW Department of Commerce
Manly Hydraulics Laboratory**

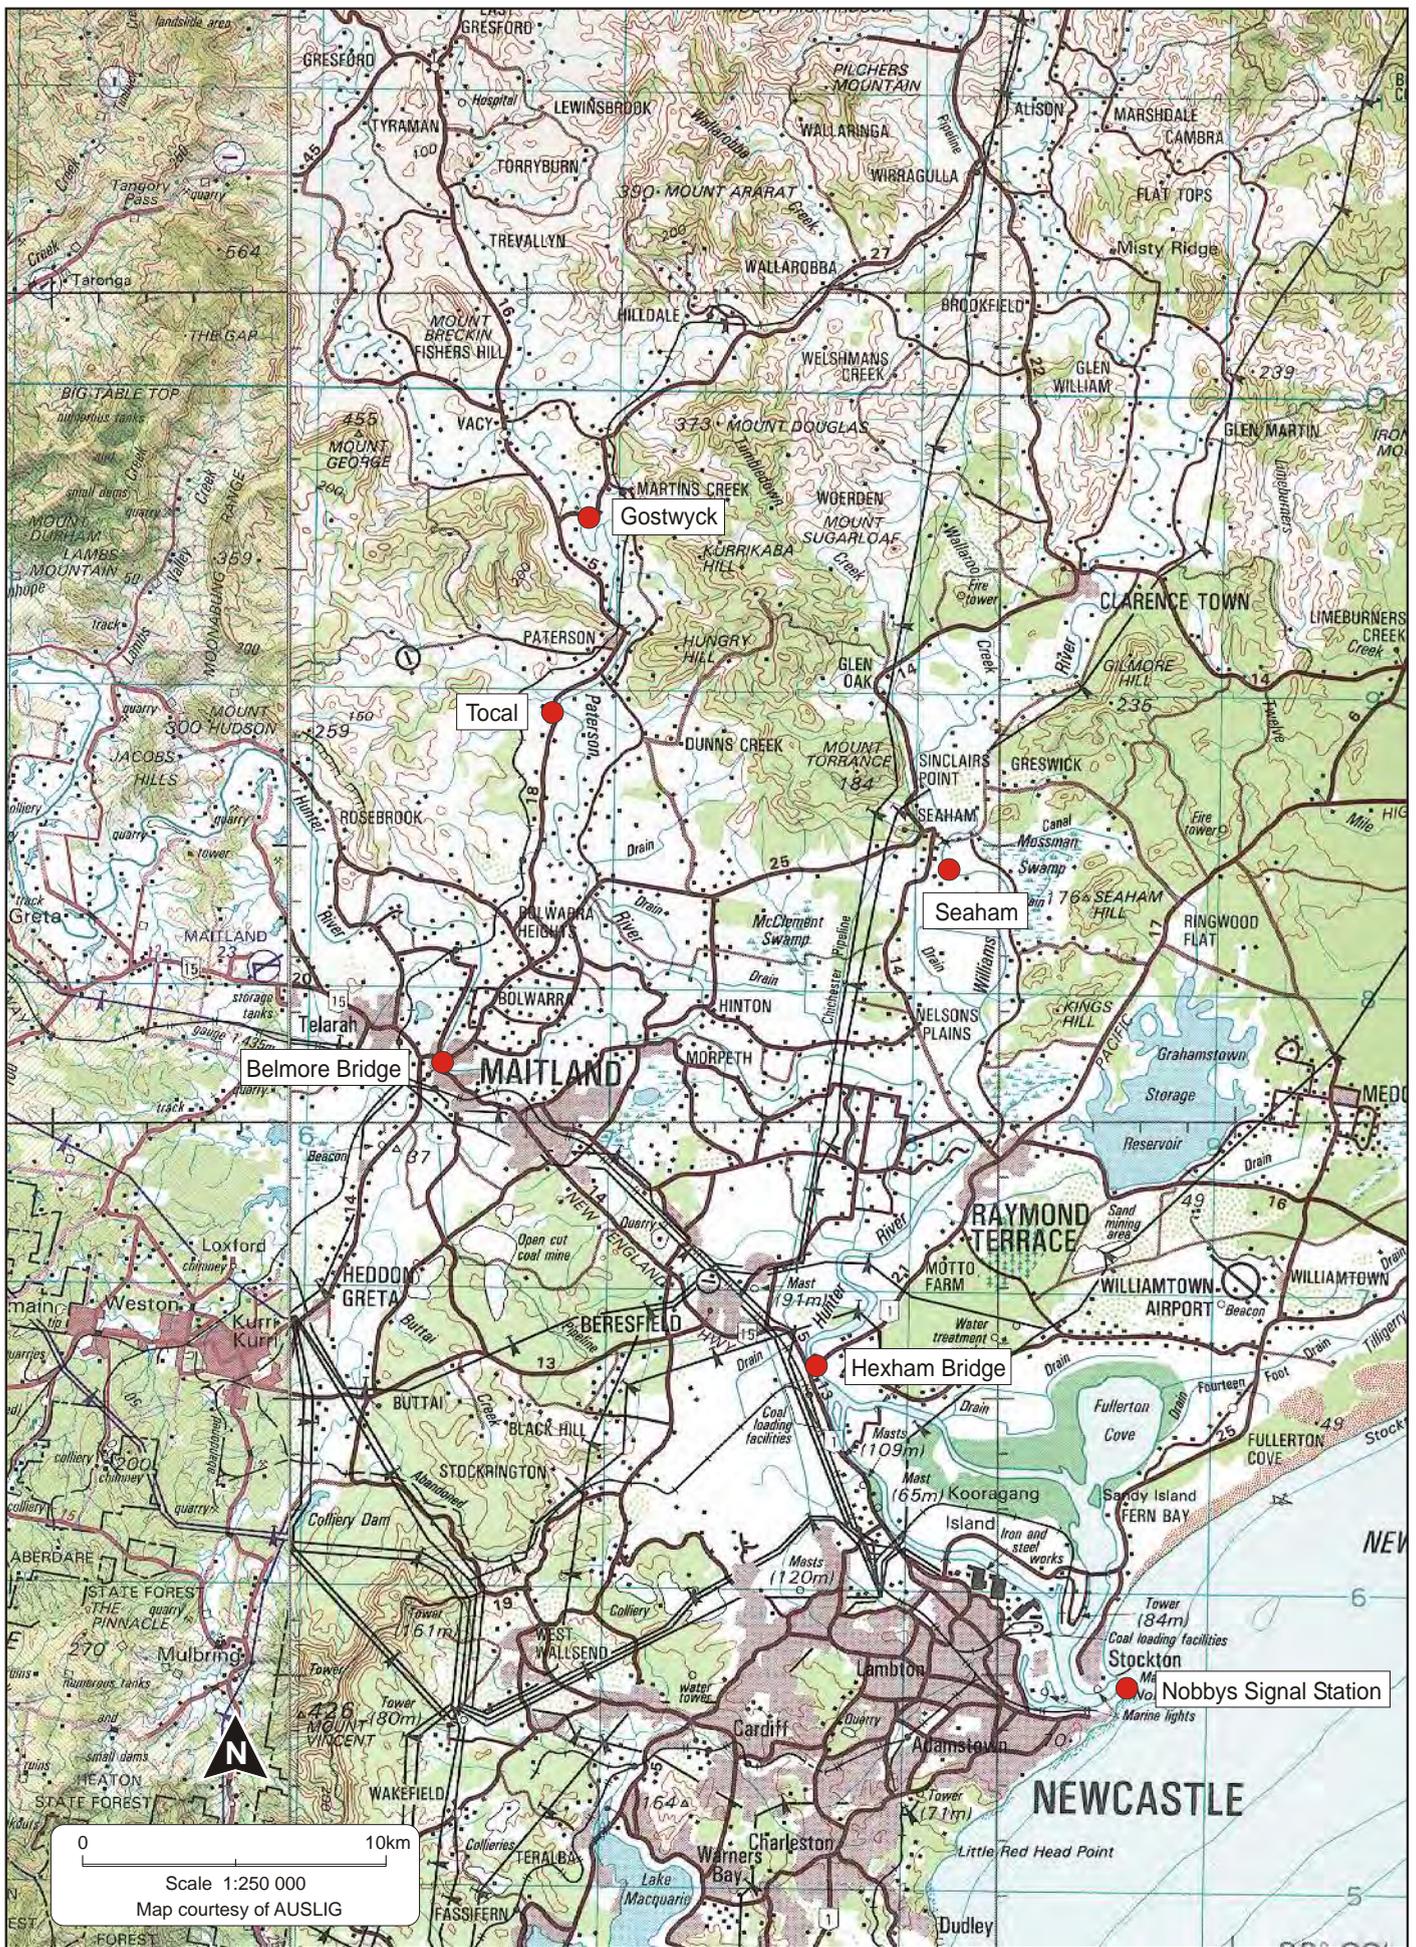
SELECTED RAINFALL STATION LOCATIONS
 IN THE HUNTER ESTUARY

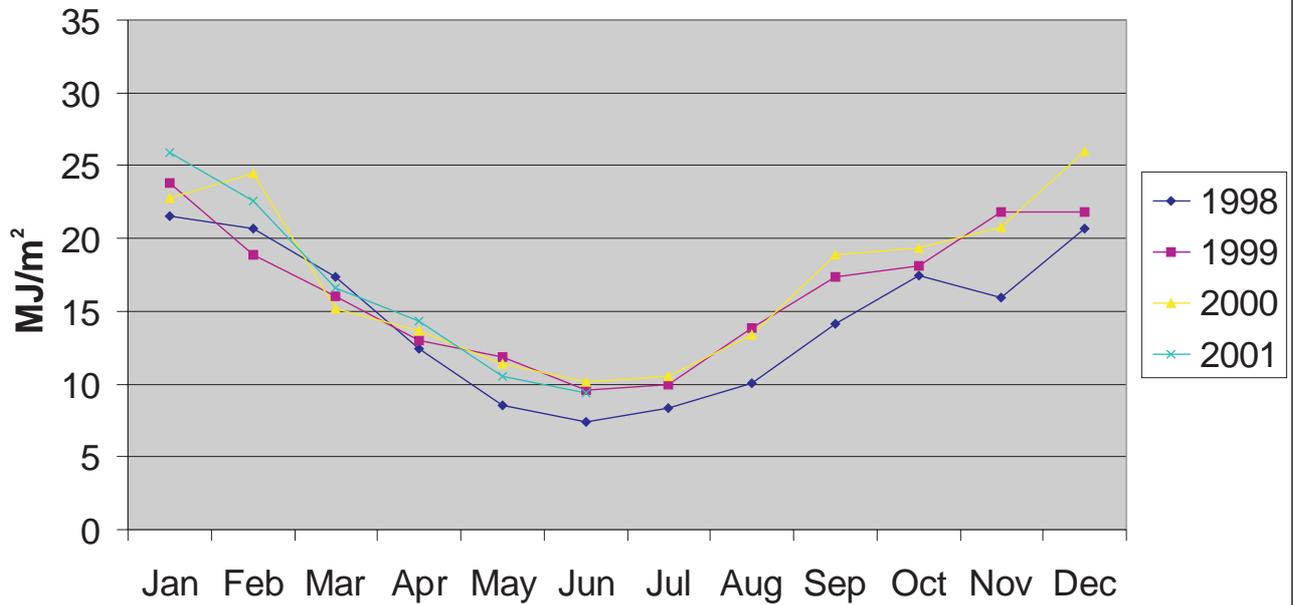
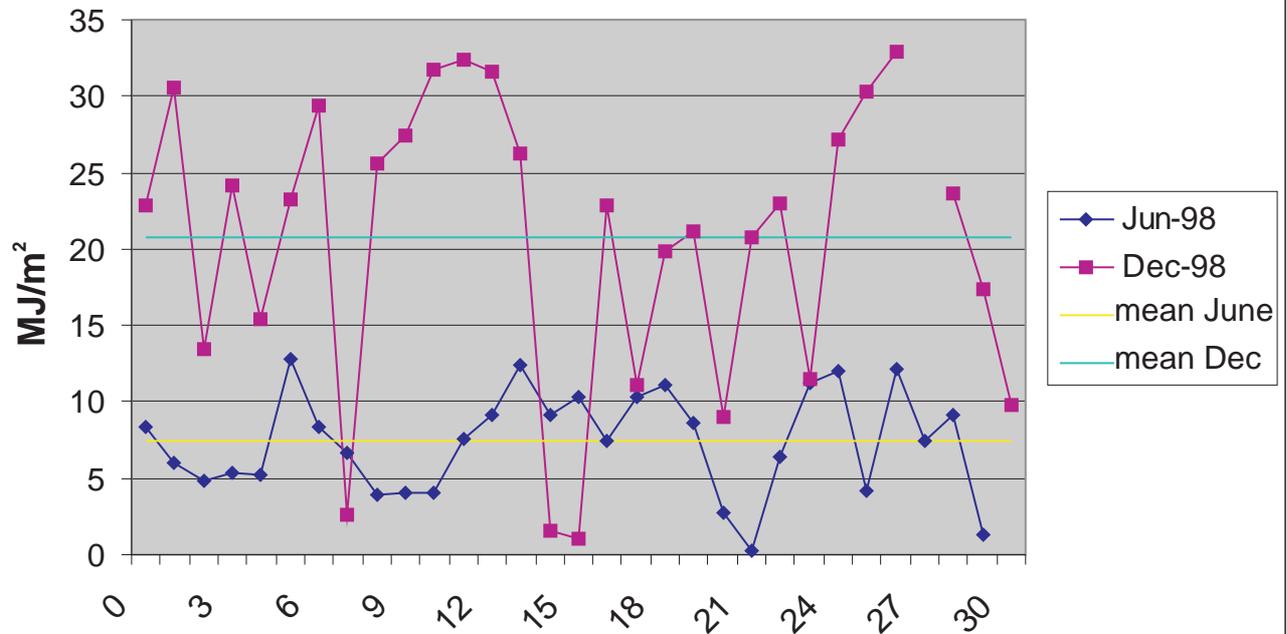
DRAWING 1095-02-02.CDR

Monthly mean

Daily mean

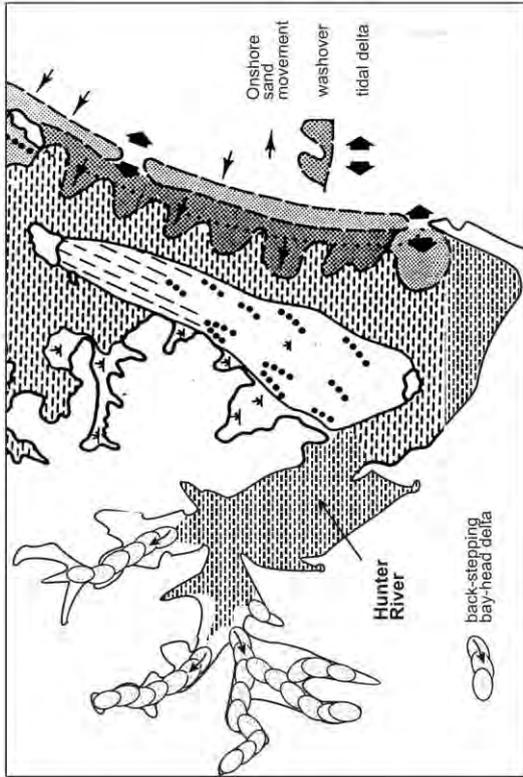
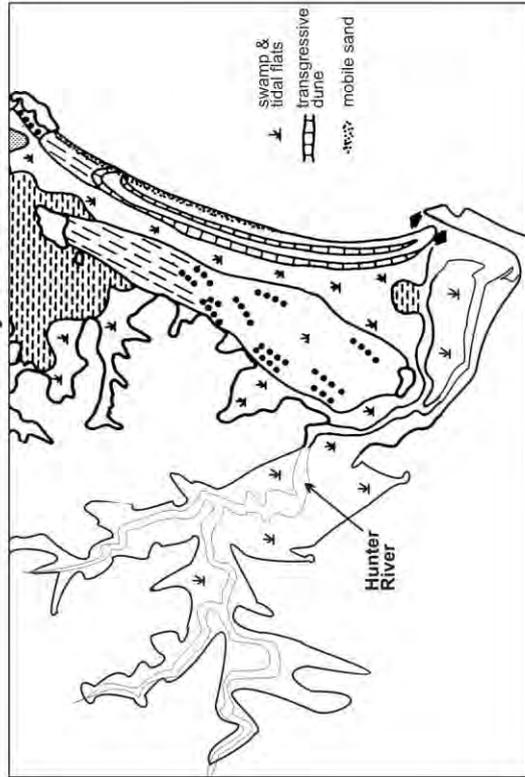
DRAWING 1095-02-06.CDR

10 000 - 6 500 yr BP

< 3 000 yr BP

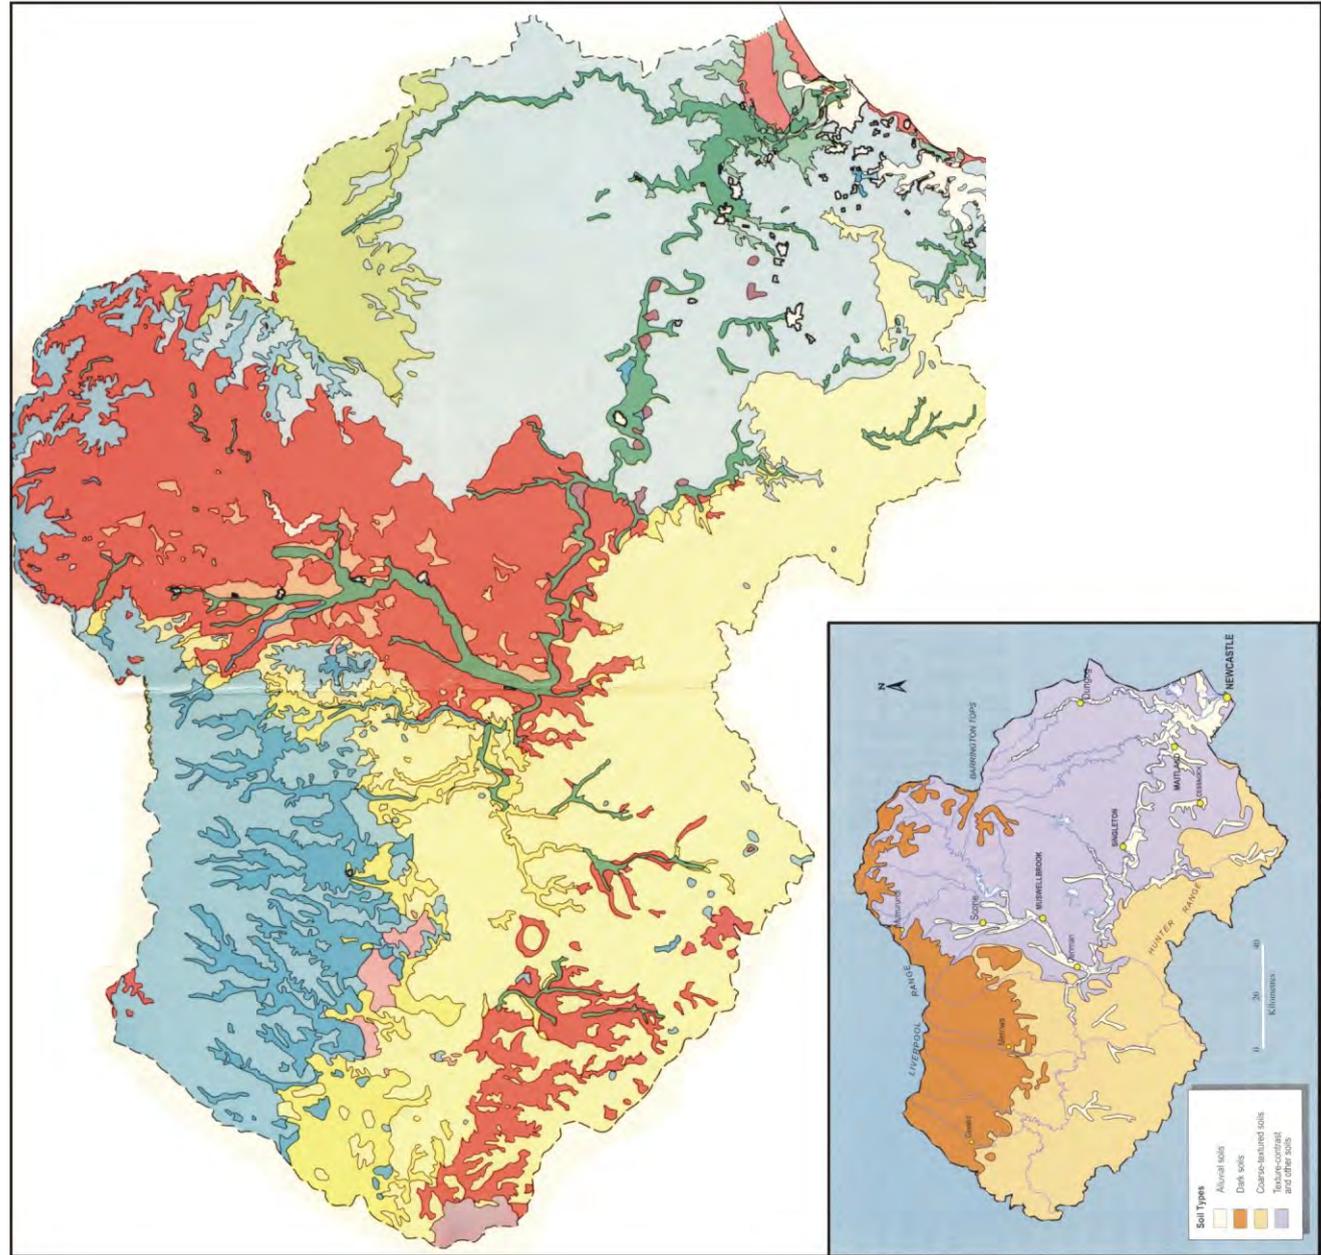
ASSOCIATIONS OF MOSTLY LEACHED SOILS

- Podzolic and skeletal soils, respectively on lower gentle slopes and on steeper slopes. Some earths. Occasional patches of cracking clays and solonchic soils. Soils shallow in steep parts

ASSOCIATIONS ON ALLUVIUM OR RIVERINE DUNES

- Various soils depending on age of terrace, composition of parent material, and climate. Chernozems, solonchic soils, cracking clays, earths, and alluvial regosols
- Badly drained soils. Acid swamp soils and meadow soils, with alluvial regosols which are mostly fine-textured and saline
- Sandy aeolian regosols, usually deep or very deep and single-grained

Alluvial soil landscapes are formed by deposition along rivers and streams. They are often found on meander plains, point bars, levees, terraces, prior and current stream channels (Matthei 1995). Alluvial soil landscapes occur in large areas of the upper Hunter estuary along the floodplain and stream channel of the Hunter River, Paterson River and Wallis/Fishery creeks (Figure 2.11). These soils are susceptible to water erosion.

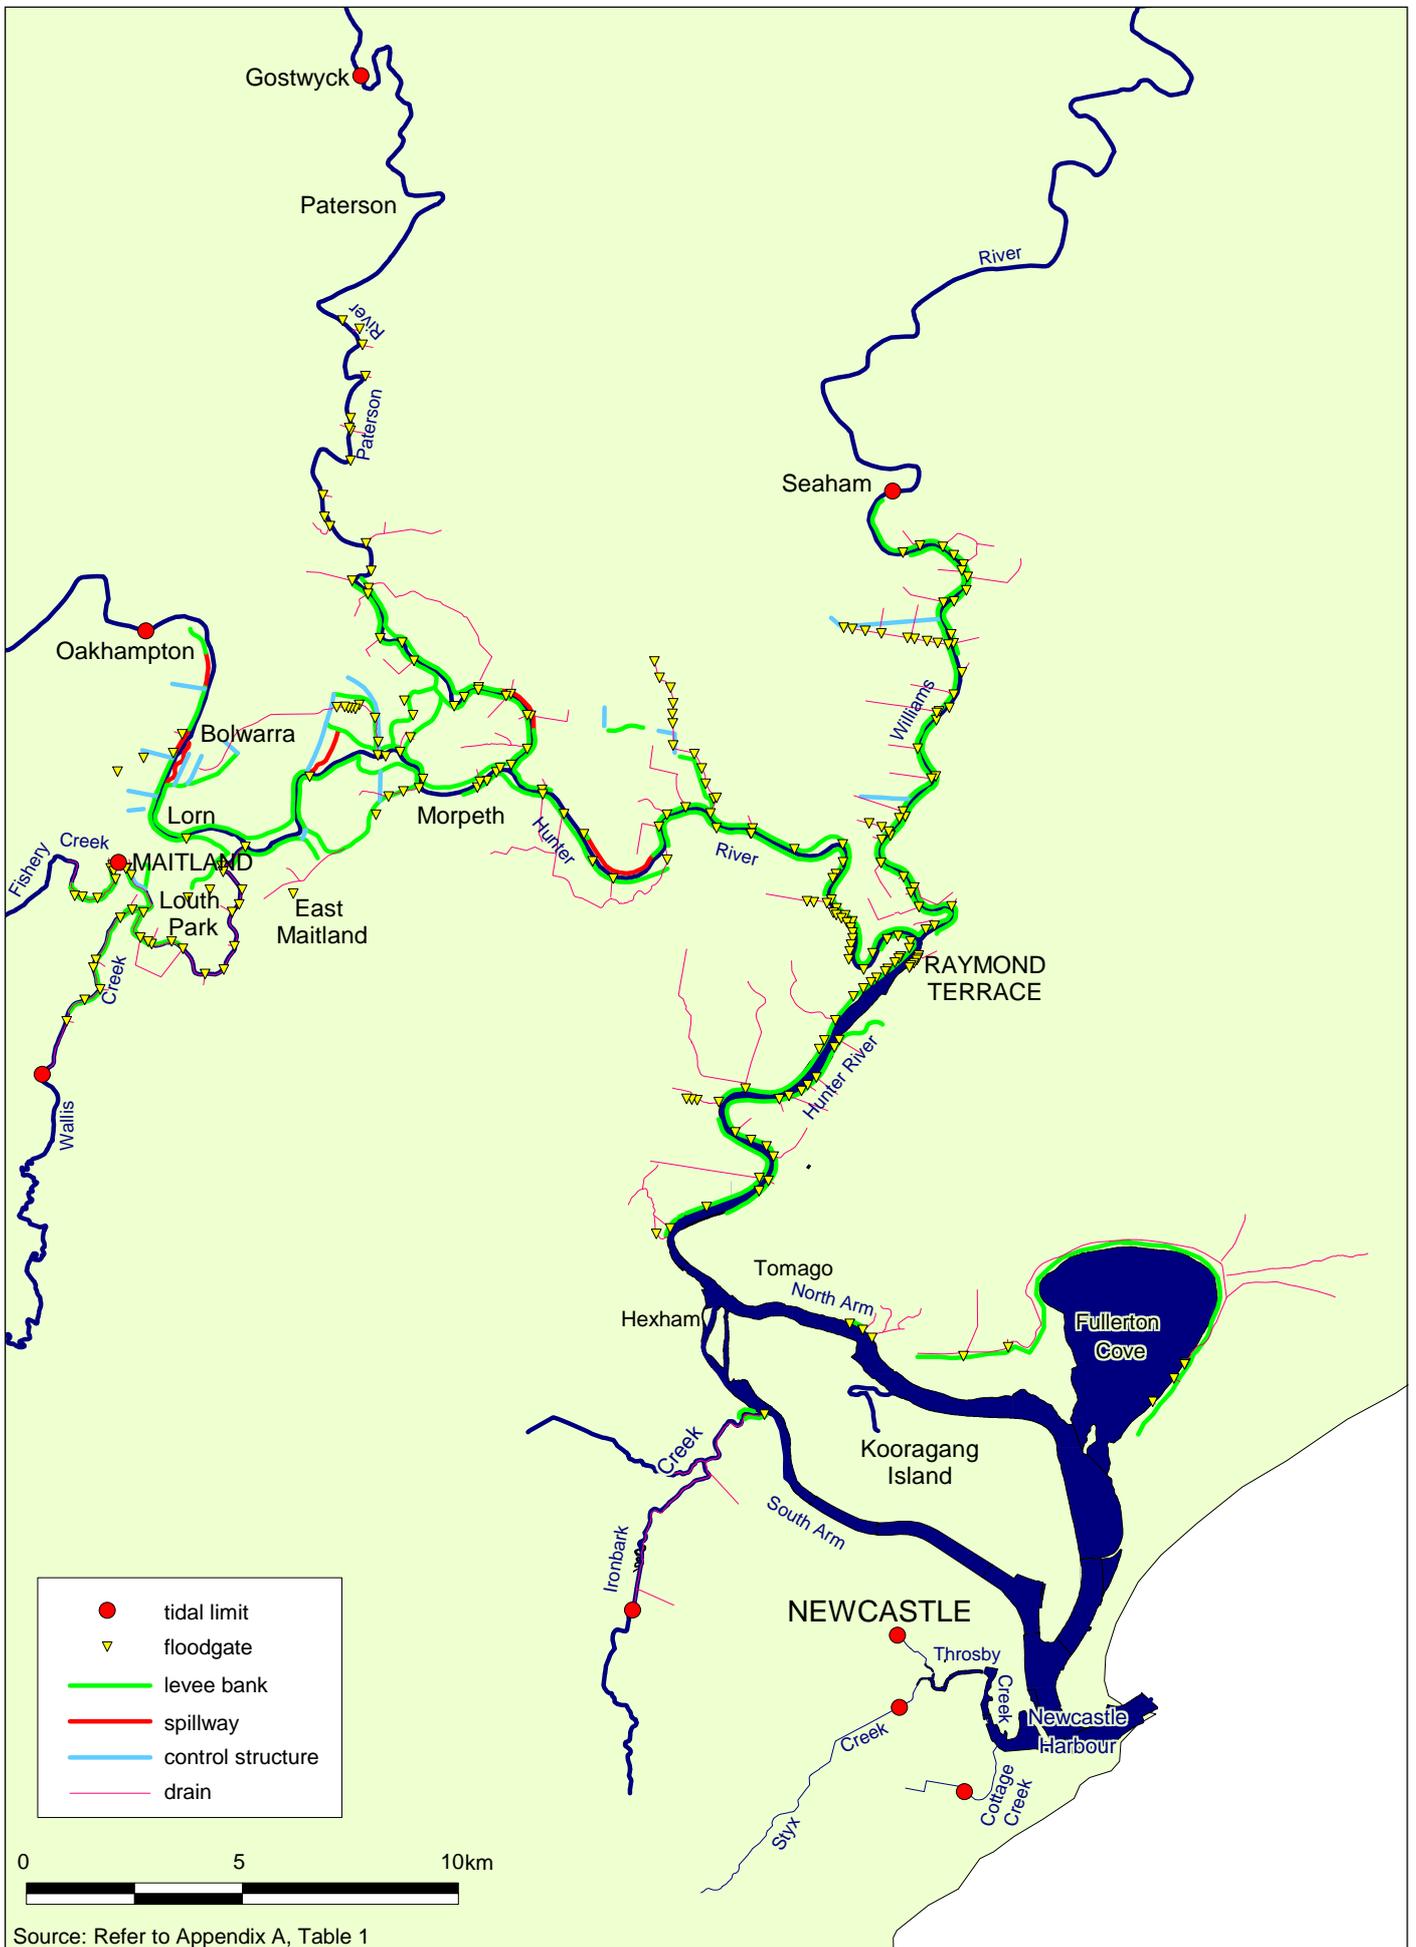
FLOOD MITIGATION STRUCTURES OF THE HUNTER ESTUARY

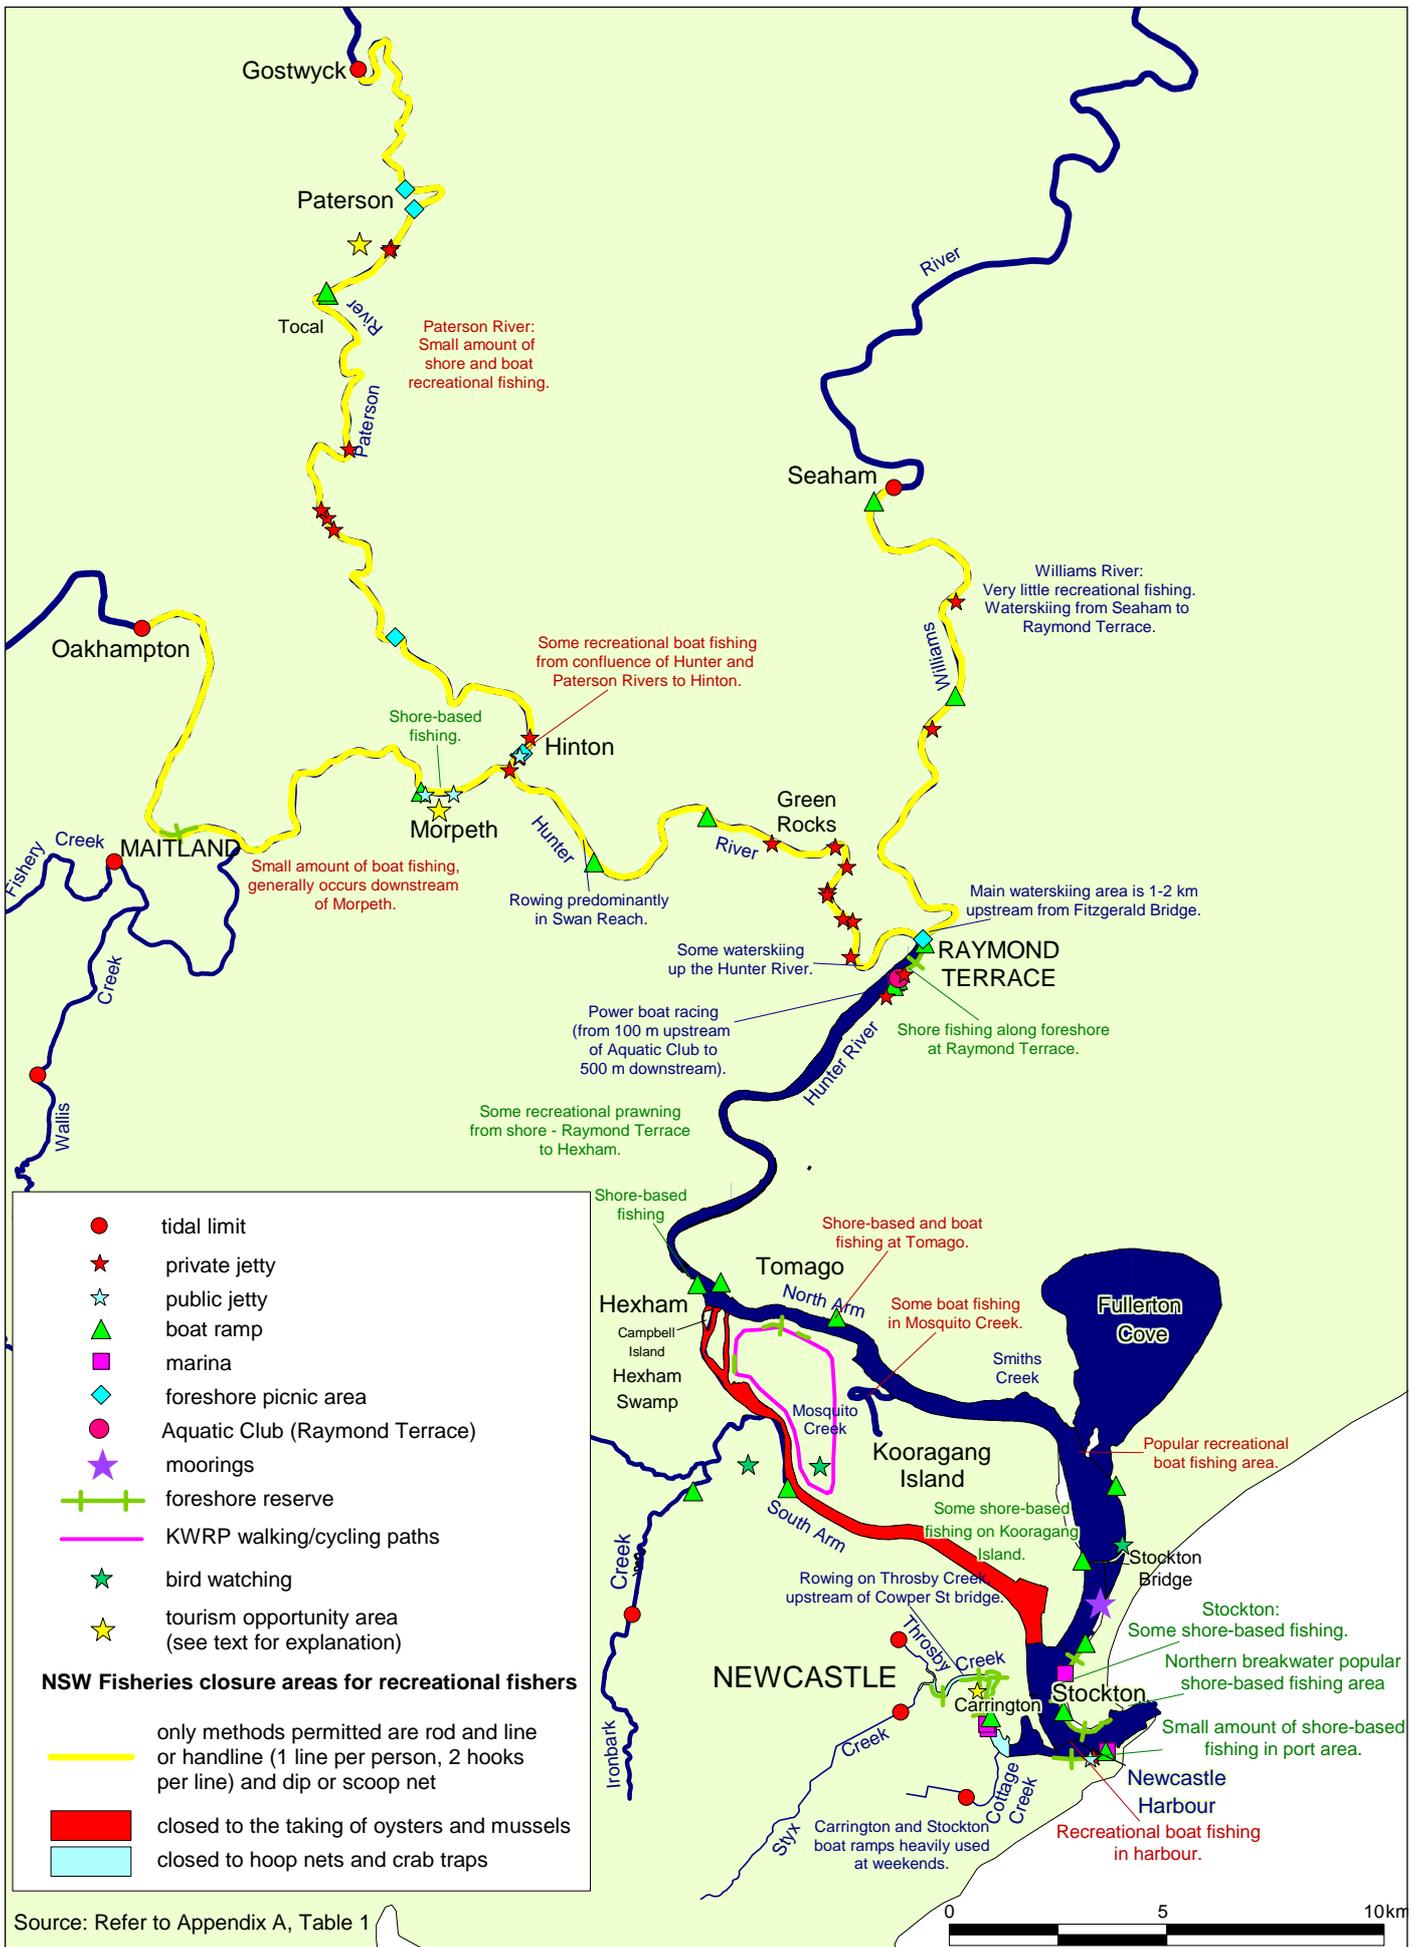
●	tidal limit
★	private jetty
☆	public jetty
▲	boat ramp
■	marina
◆	foreshore picnic area
●	Aquatic Club (Raymond Terrace)
☆	moorings
+	foreshore reserve
—	KWRP walking/cycling paths
★	bird watching
☆	tourism opportunity area (see text for explanation)
NSW Fisheries closure areas for recreational fishers	
— (yellow)	only methods permitted are rod and line or handline (1 line per person, 2 hooks per line) and dip or scoop net
— (red)	closed to the taking of oysters and mussels
— (cyan)	closed to hoop nets and crab traps

RECREATIONAL ACTIVITIES ON THE HUNTER ESTUARY

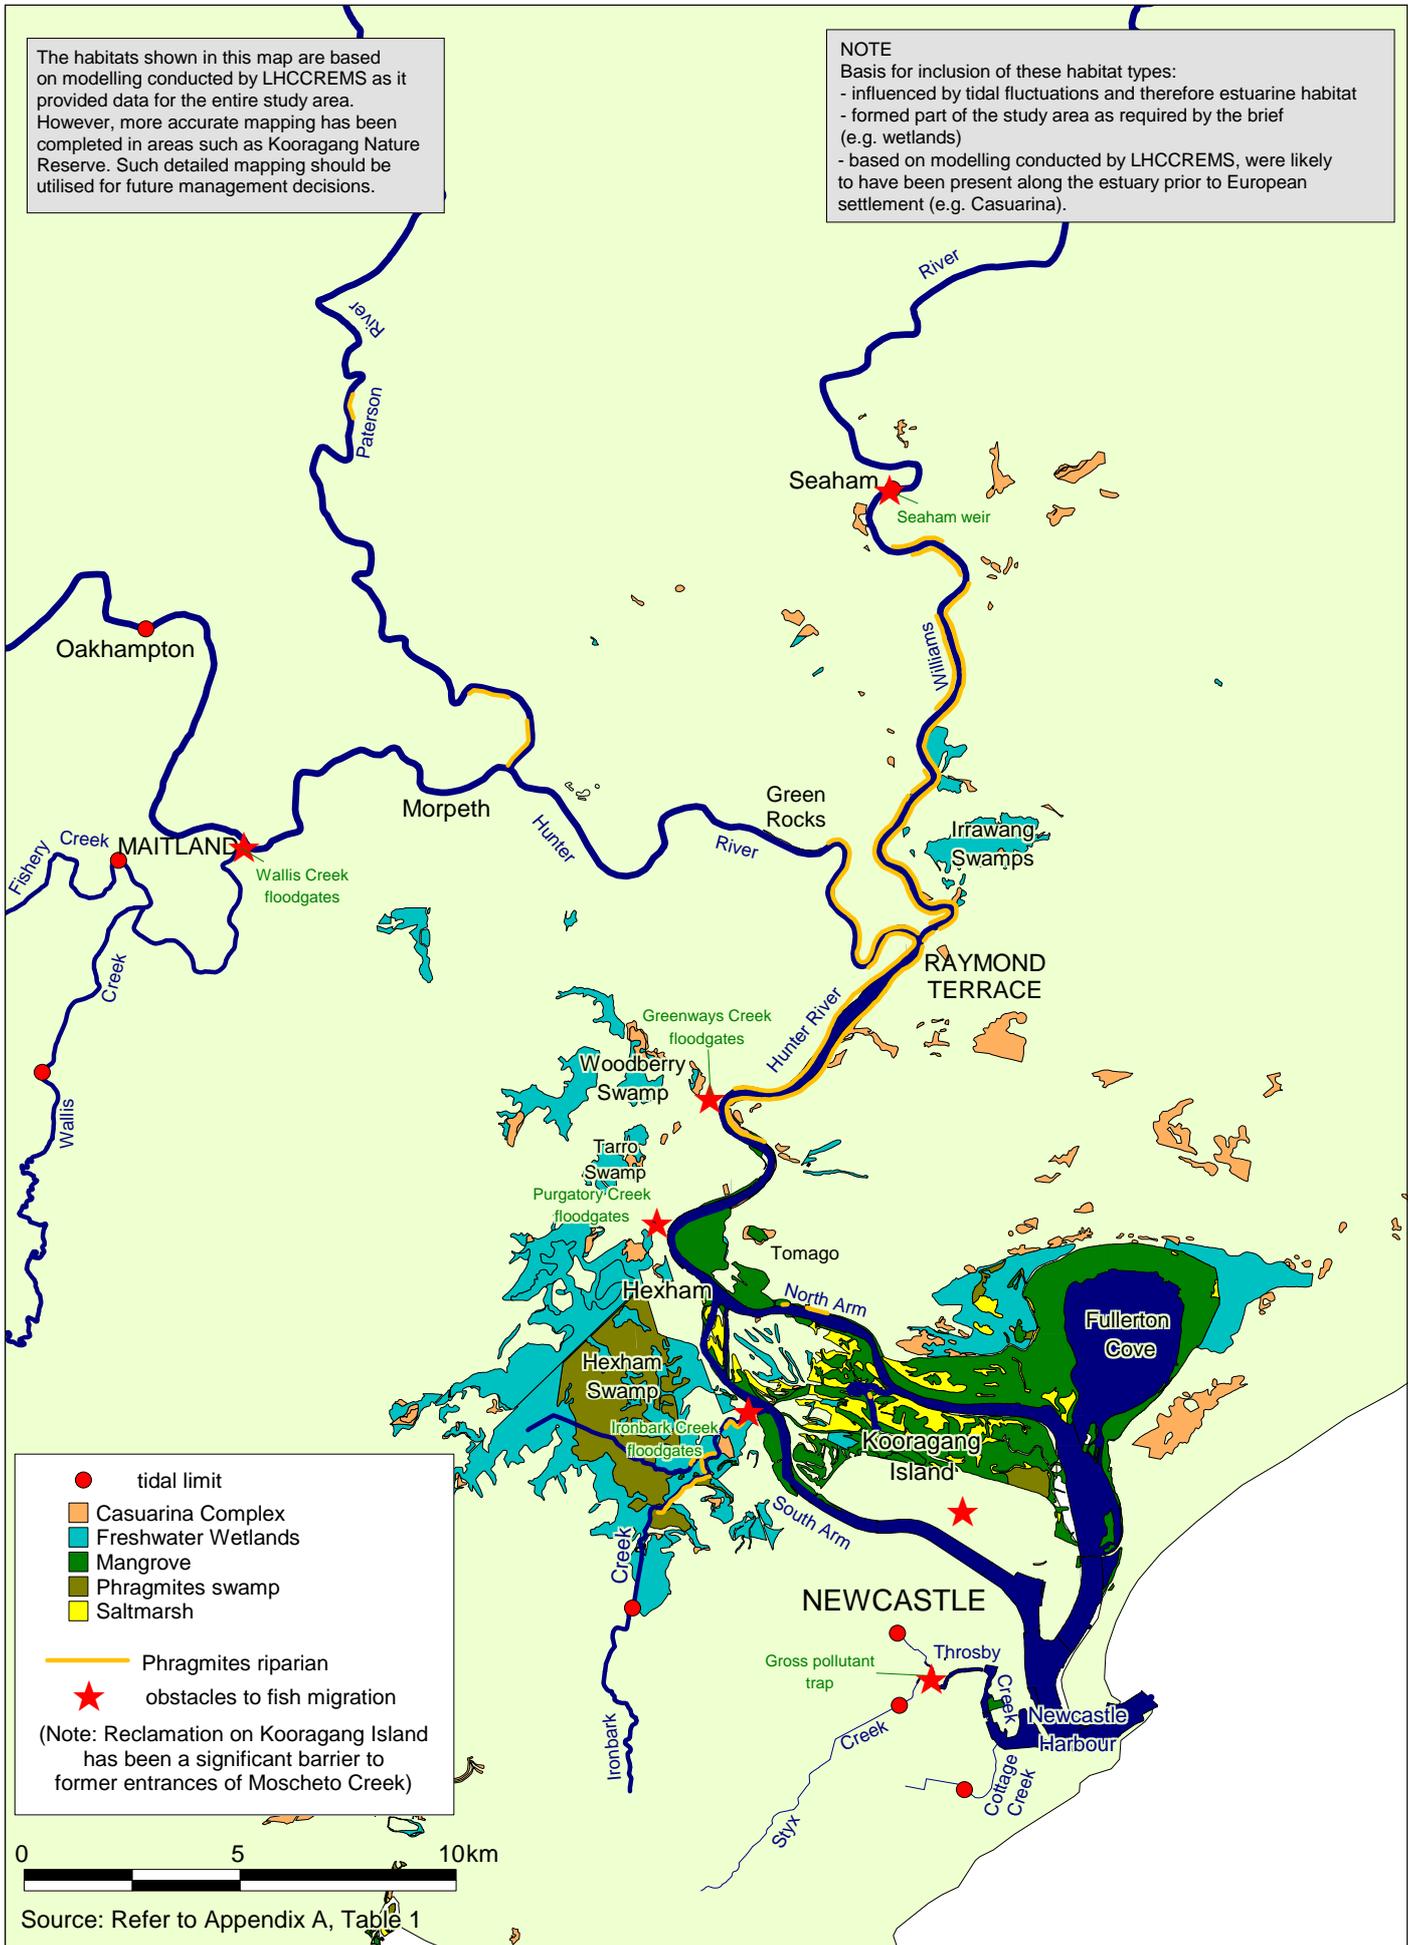
- tidal limit
- Casuarina Complex
- Freshwater Wetlands
- Mangrove
- Phragmites swamp
- Saltmarsh
- Phragmites riparian
- ★ obstacles to fish migration

(Note: Reclamation on Kooragang Island has been a significant barrier to former entrances of Moscheto Creek)

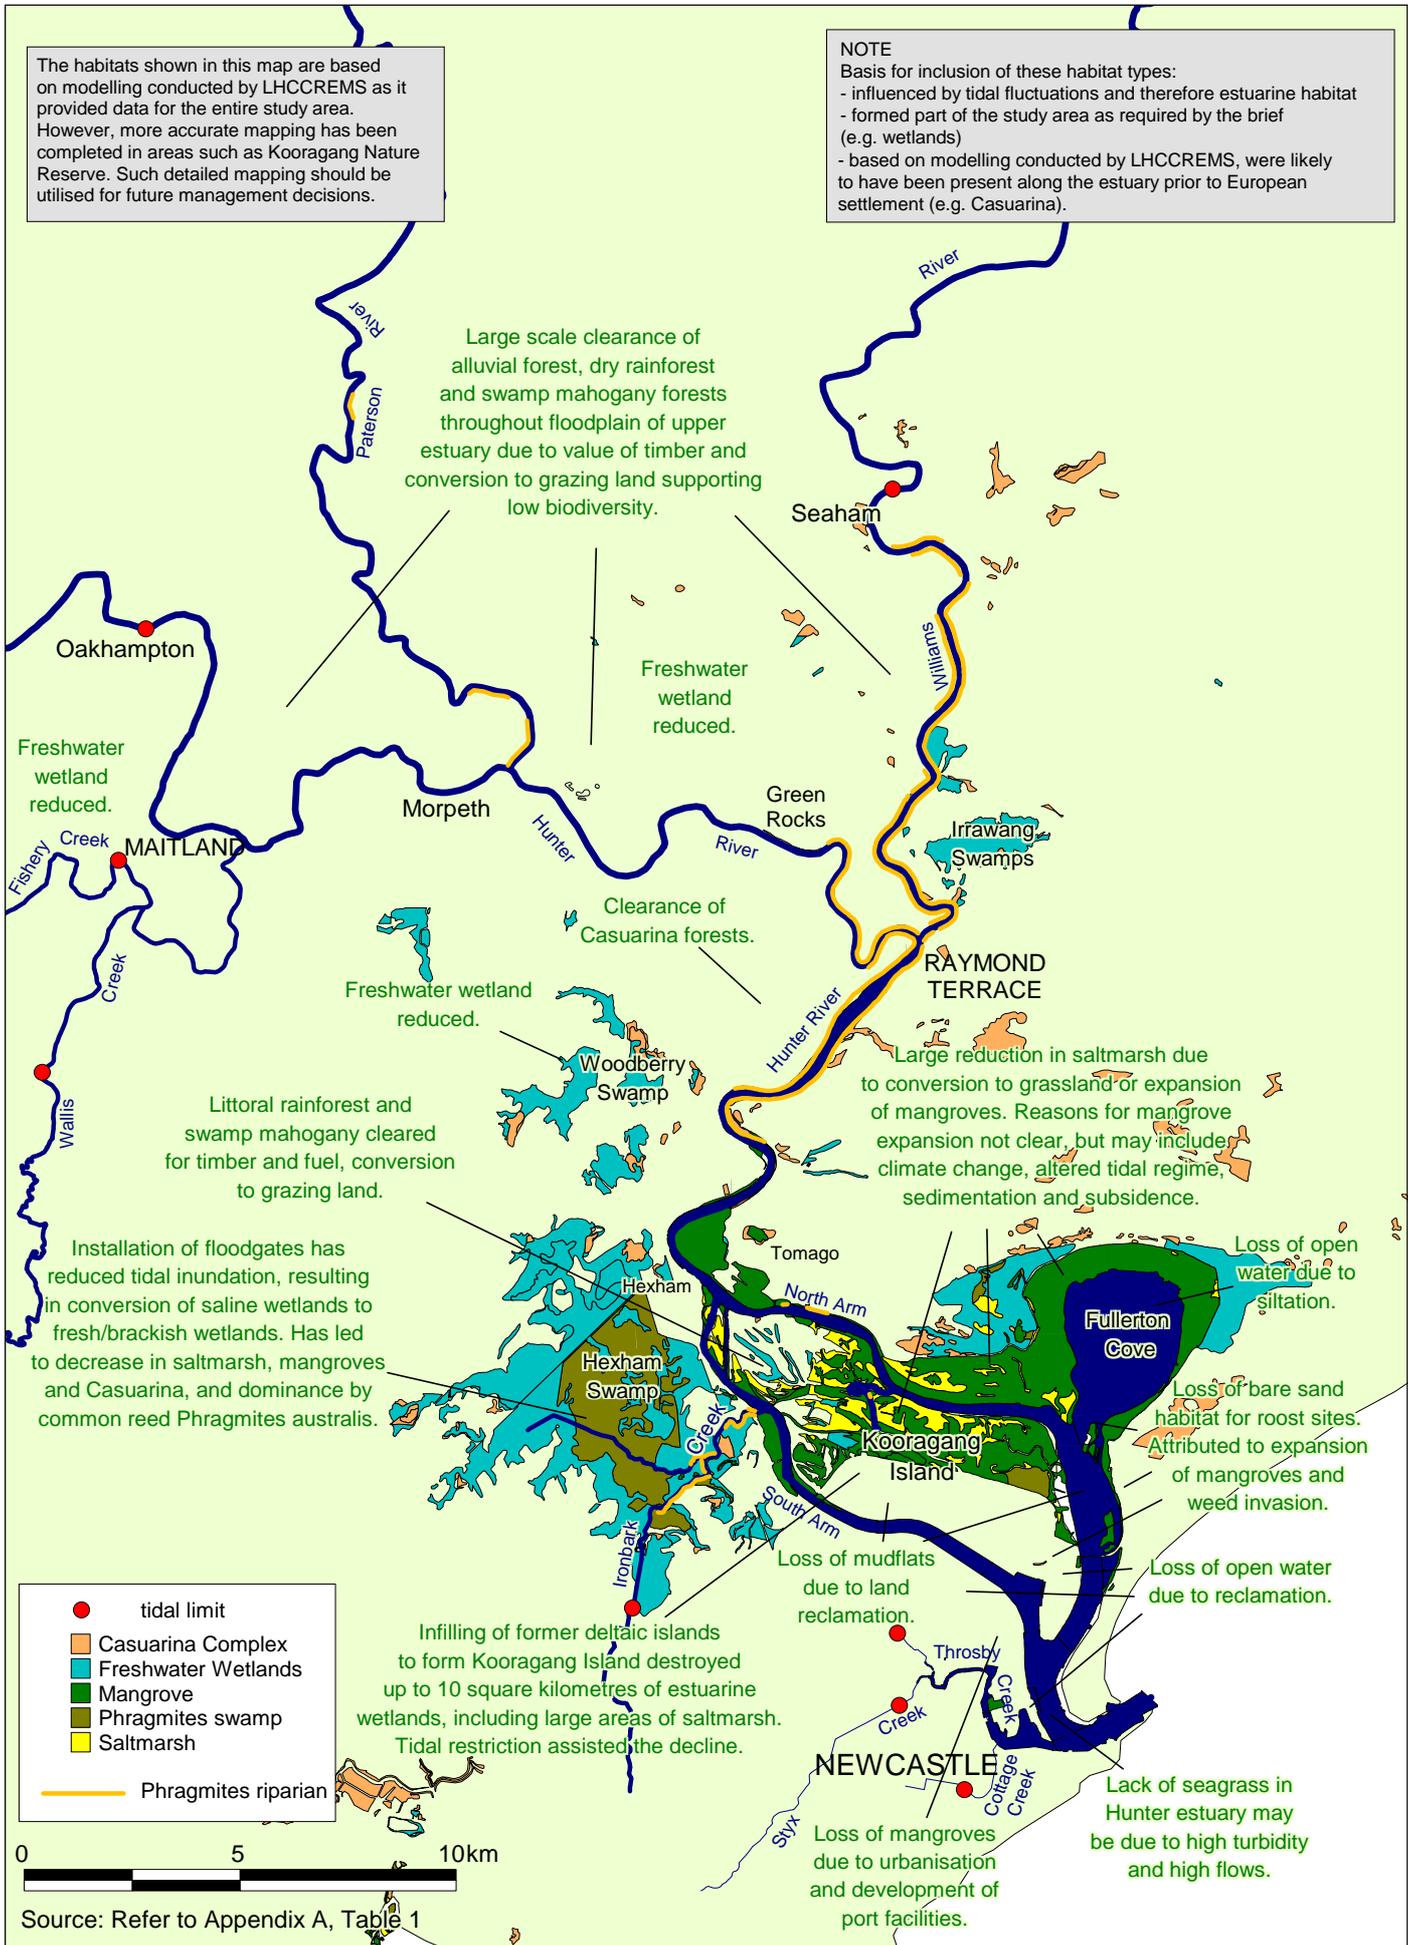
CHANGES TO HABITAT DIVERSITY SINCE EUROPEAN SETTLEMENT
