Anna Bay and Tilligerry Creek Flood Study Final Report

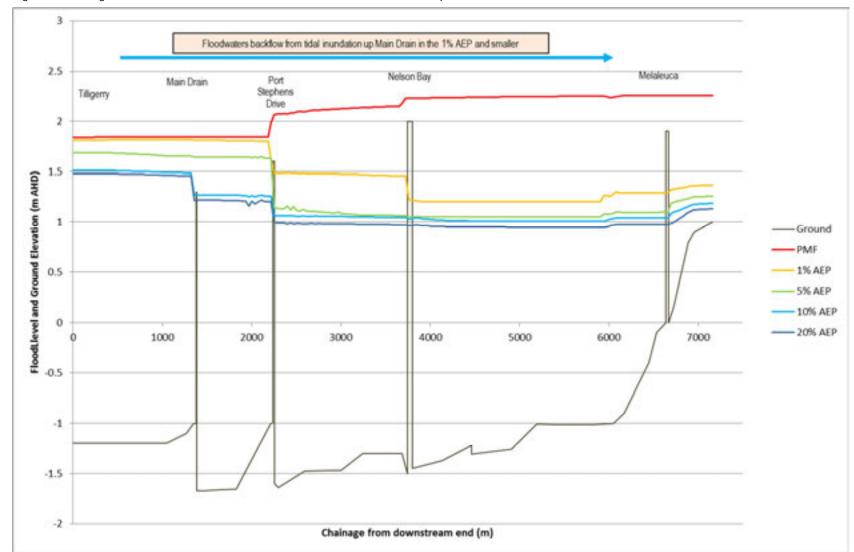
Figure E-22 Design Water Level Profiles – Main Drain – Current climate and development conditions

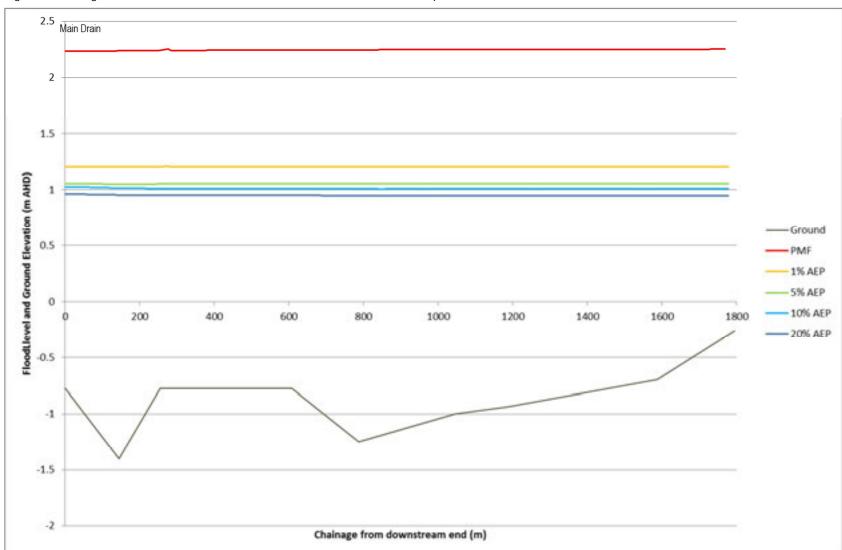
Figure E-23 Design Water Level Profiles – Back Drain – Current climate and development conditions

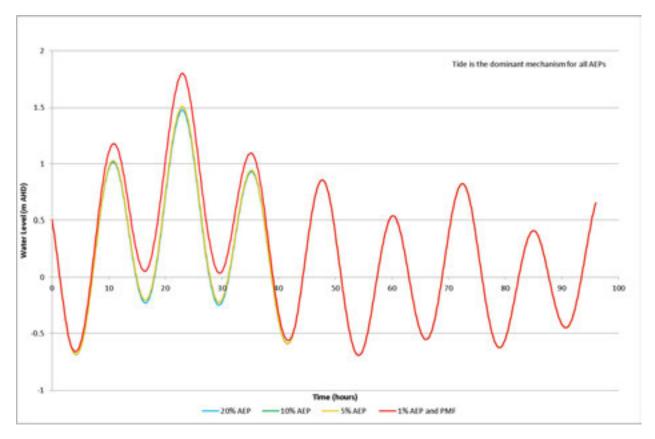
Figure E-27 Flood Level versus Time – Tilligerry Creek upstream – Current day conditions

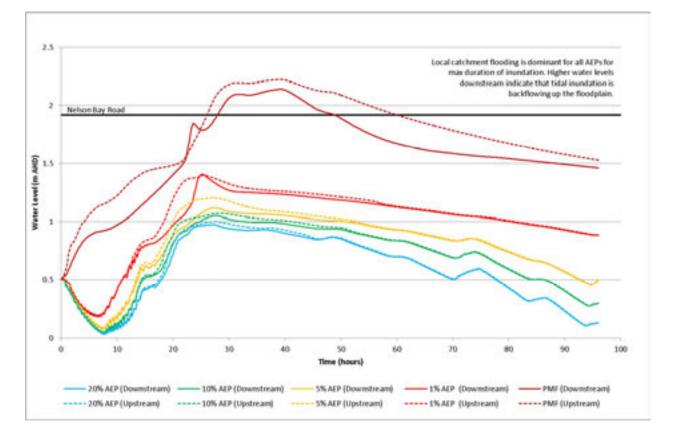
Figure E-29 Flood Level versus Time – Nelson Bay Road 850m north of Gan Gan Road south end – Current day conditions

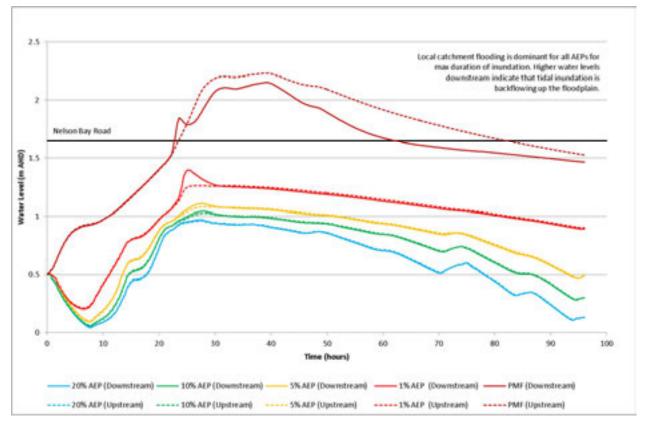
Figure E-30 Flood Level versus Time – Nelson Bay Road 270m north of Gan Gan Road south end – Current day conditions

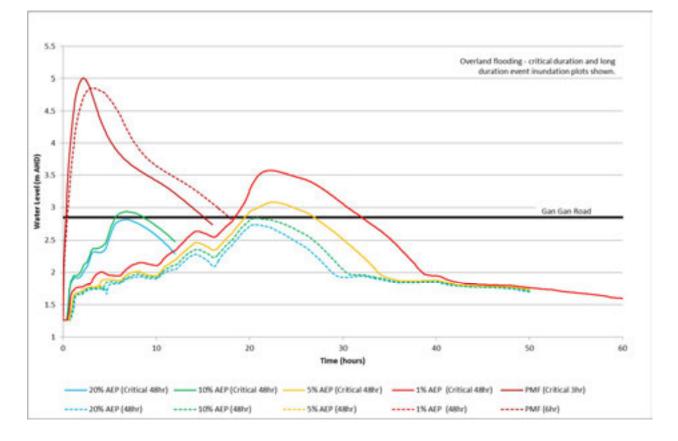
Figure E-31 Flood Level versus Time – McKinley Swamp – Current day conditions

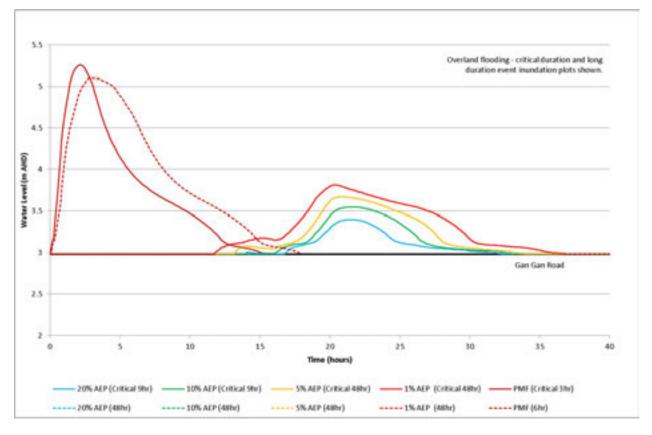
Figure E-33 Flood Level versus Time – Gan Gan Road Clark Street low point – Current day conditions

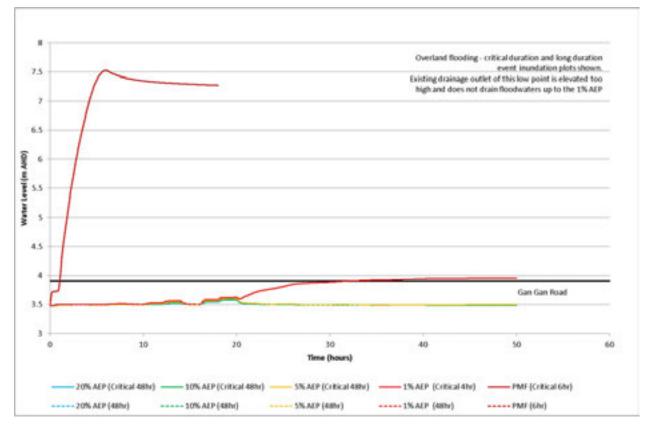
Figure E-35 Flood Level versus Time – Marsh Road 1.5km from Nelson Bay Road east end – Current day conditions

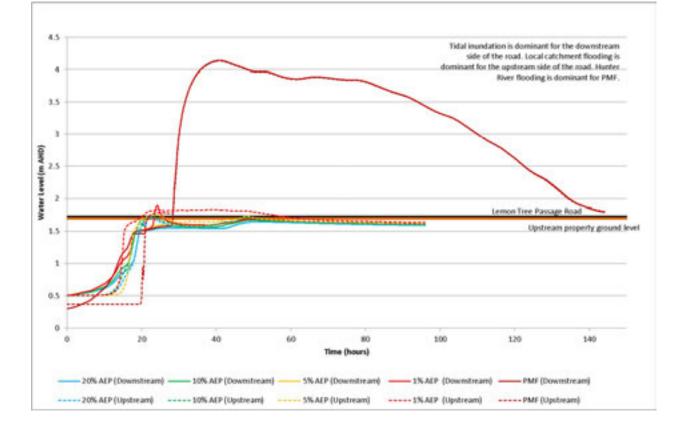
Figure E-37 Flood Level versus Time – Lemon Tree Passage Road 100m north of Michael Drive – Current day conditions

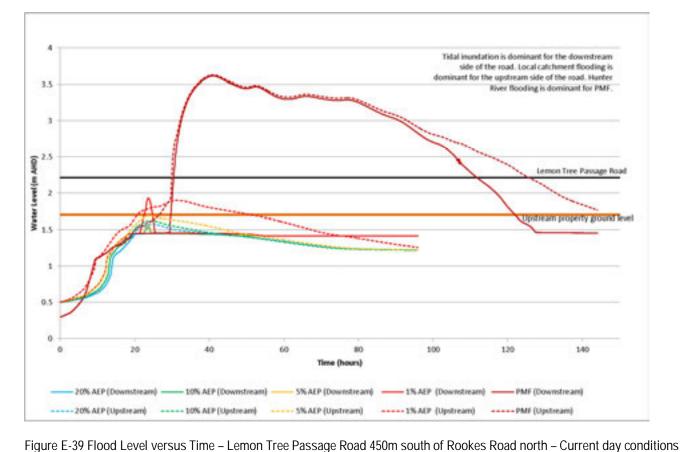
3.5 Tidal inundation is dominant for the downstream side of the road. Local catchment flooding is dominant for the upstream side of the road. Hunter River flooding is dominant for PMF. 3 2.5

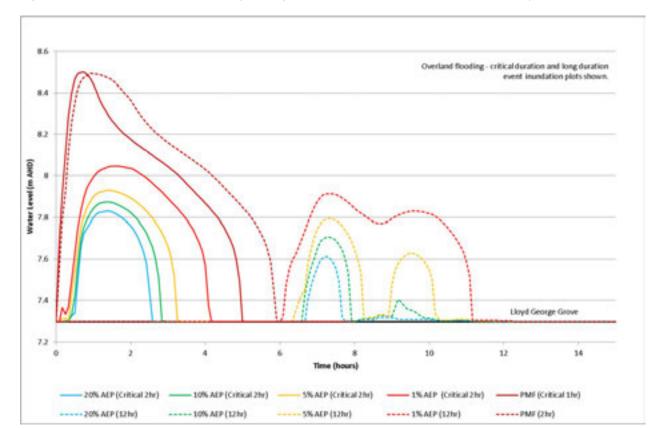
Figure E-41 Flood Level versus Time – Lloyd George Grove at President Wilson Walk – Current day conditions

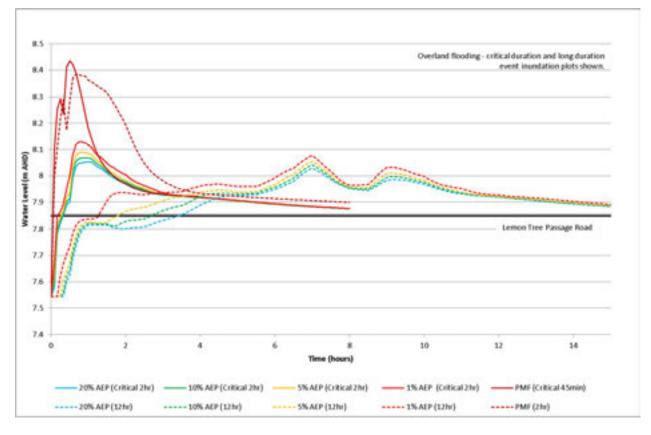
Figure E-43 Flood Level versus Time – Shearman Avenue near Mackie Street – Current day conditions

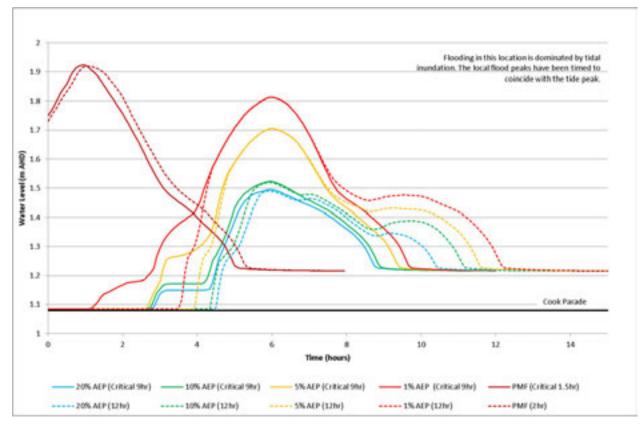
Figure E-45 Flood Level versus Time - Paroa Avenue - Current day conditions

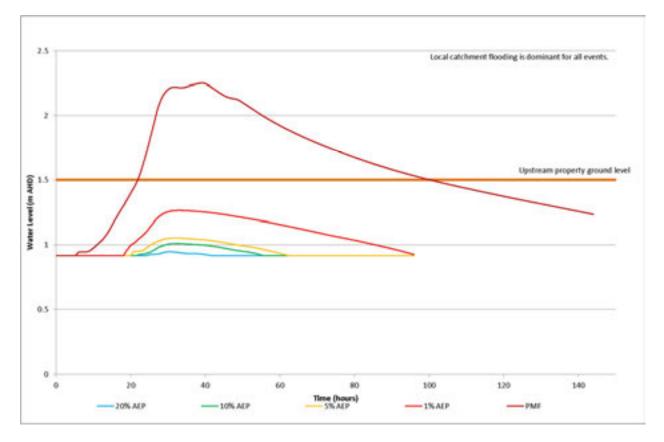
Figure E-46 Flood Level versus Time - One Mile residential - Main Drain - Current day conditions
