## Appendix D

E012 – Sand Management Action  
Details

## Management Action E012 – Sand Management Action

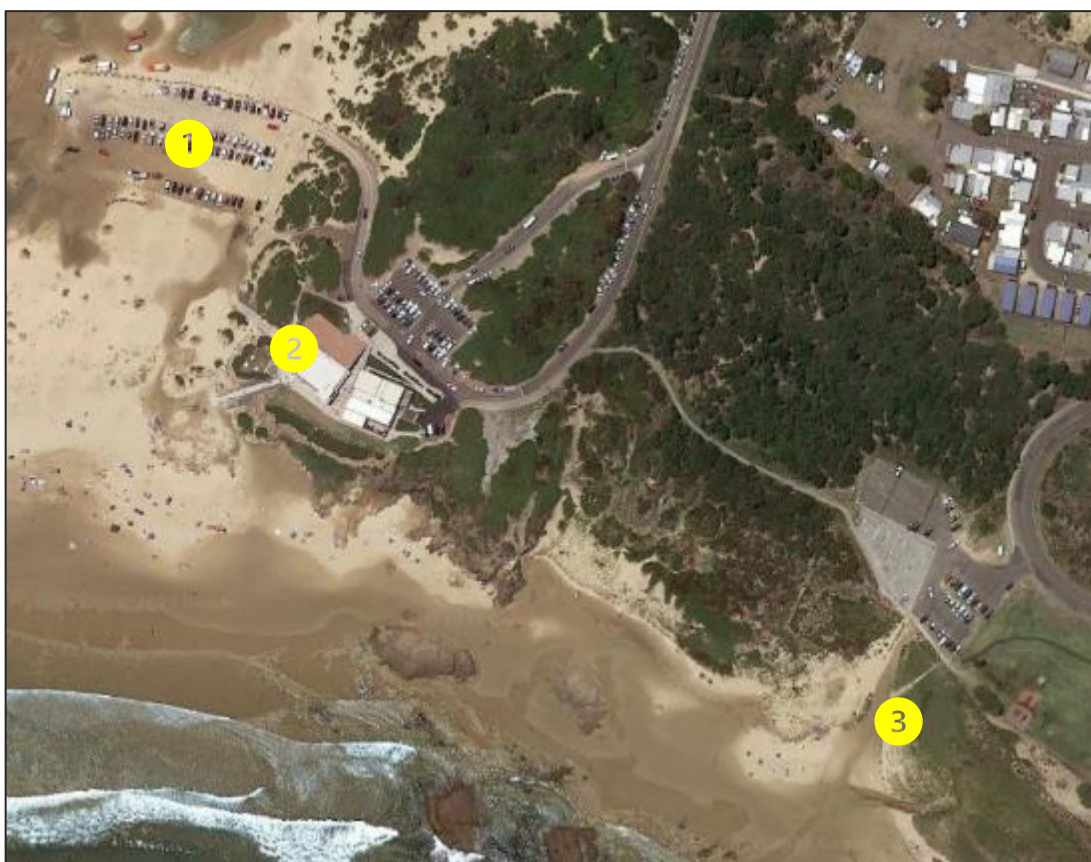
Figure D-1 – Birubi Point Sand Management Activities

1. Removal of accreted sand from the car park, usually four times a year. The cost of removal of accreted sand under Items 1 and 2 is estimated at around \$5,000 each time.
2. Removal of accreted sand from around the SLSC, usually four times a year.
3. Management of sand accreted in drainage channel and beach scraping around the boat ramp. The works are usually undertaken twice a year (at an estimated cost of \$3,000 each time) after a big swell or coastal storm event where debris and sand accumulate in the playground and at the boat ramp. Clearing of the stormwater outlet/channel is undertaken to ensure Robinson Reserve can drain freely. Sand is pushed onto the adjacent beach.

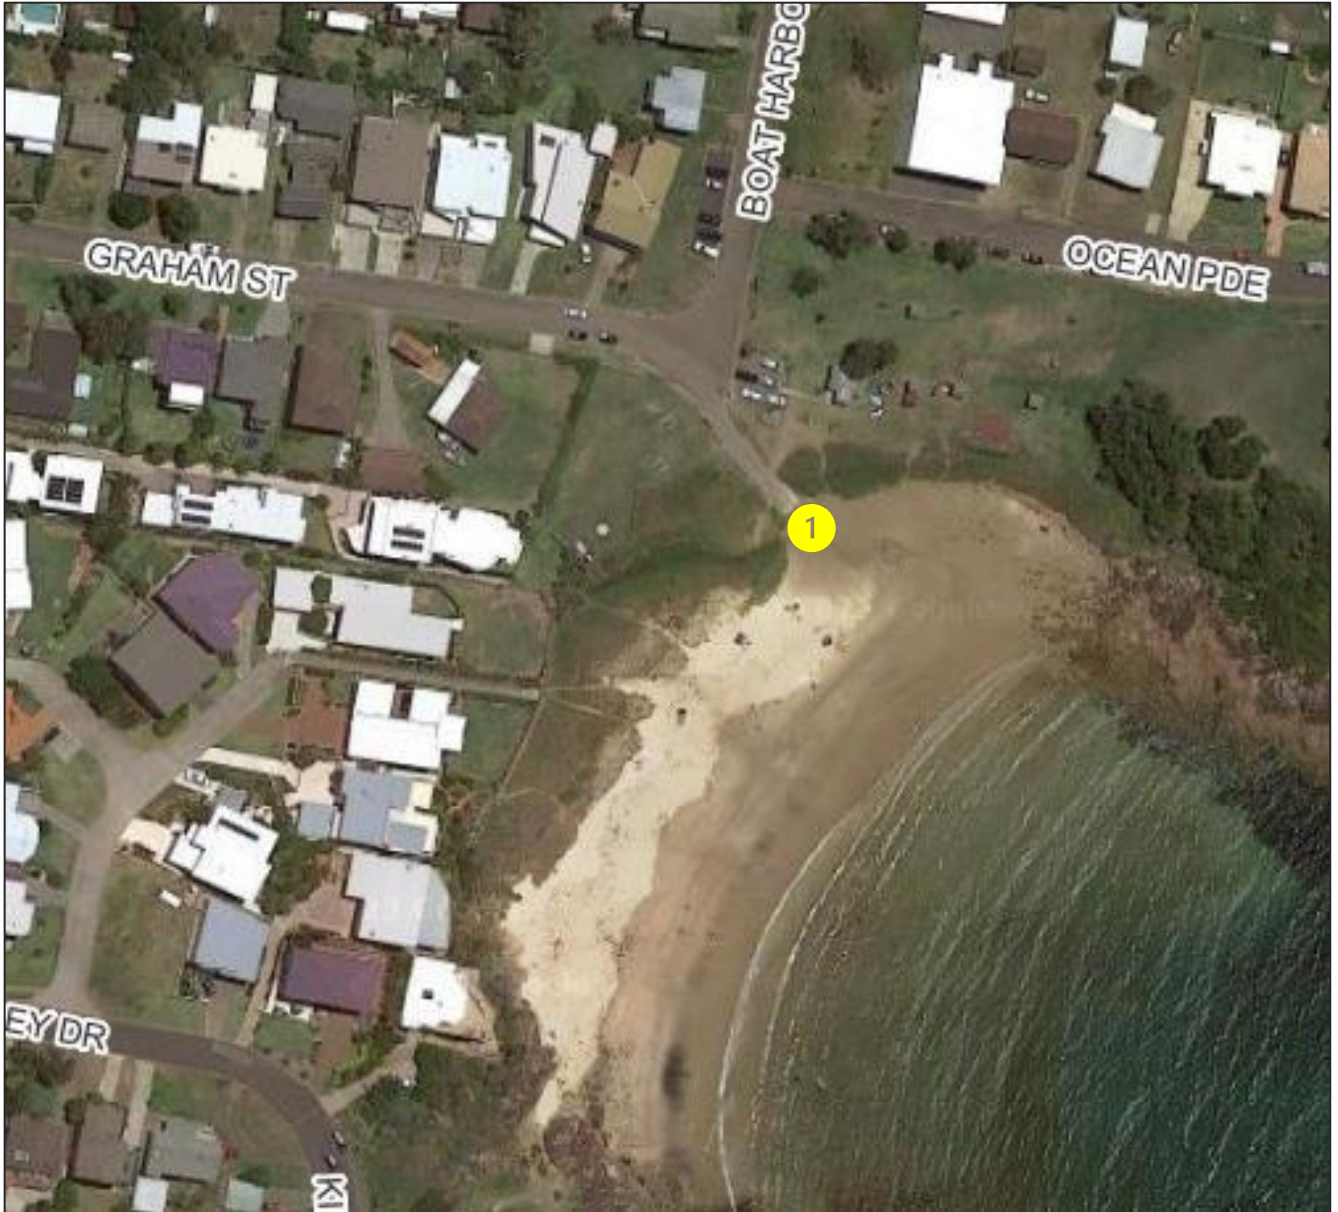
Figure D-2 – Boat Harbour Sand Management Activity

1. Stormwater causes beach erosion at the toe of the boat ramp. Beach scraping is undertaken to address this issue around twice each year at a cost of around \$3,000 each time.

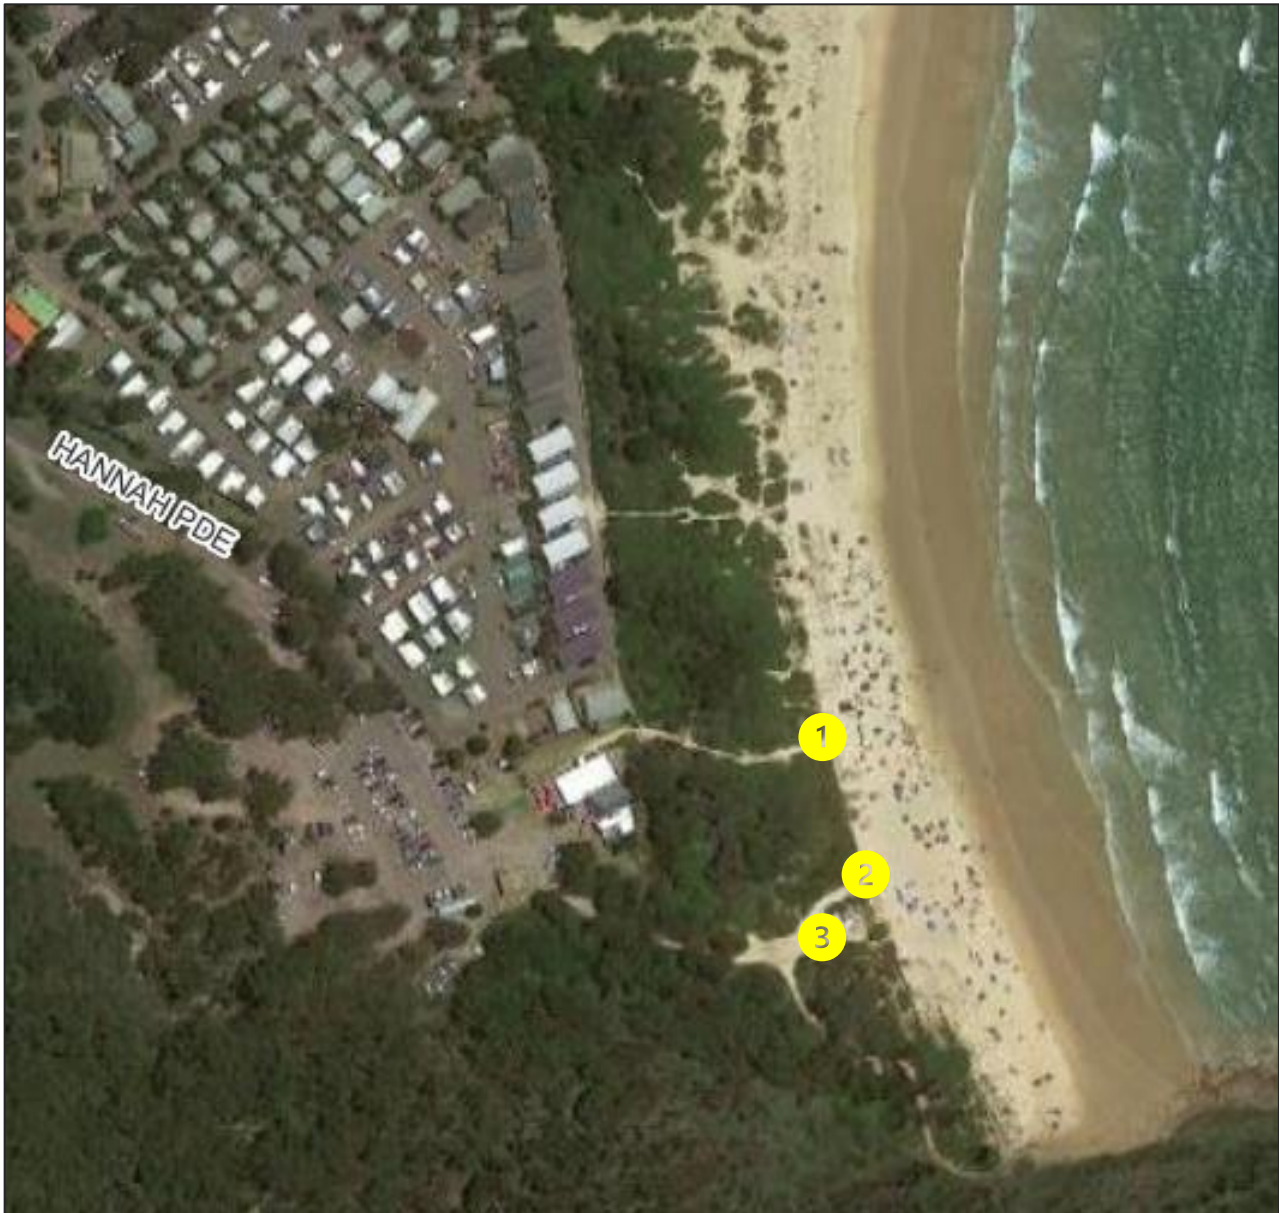
**Figure D-3 – One Mile Beach Sand Management Activities**

1. Beach scraping to address erosion at the base of stairs/accessways at a cost of around \$3,000 each time.
2. Beach scraping to reprofile where sand erodes at the location where the SLSC brings their equipment (e.g., ATVs) down to the beach. This is estimated to cost around \$30,000 and be undertaken twice a year.
3. Removal of accreted sand from around the SLSC, usually twice a year at a cost of around \$3,000.

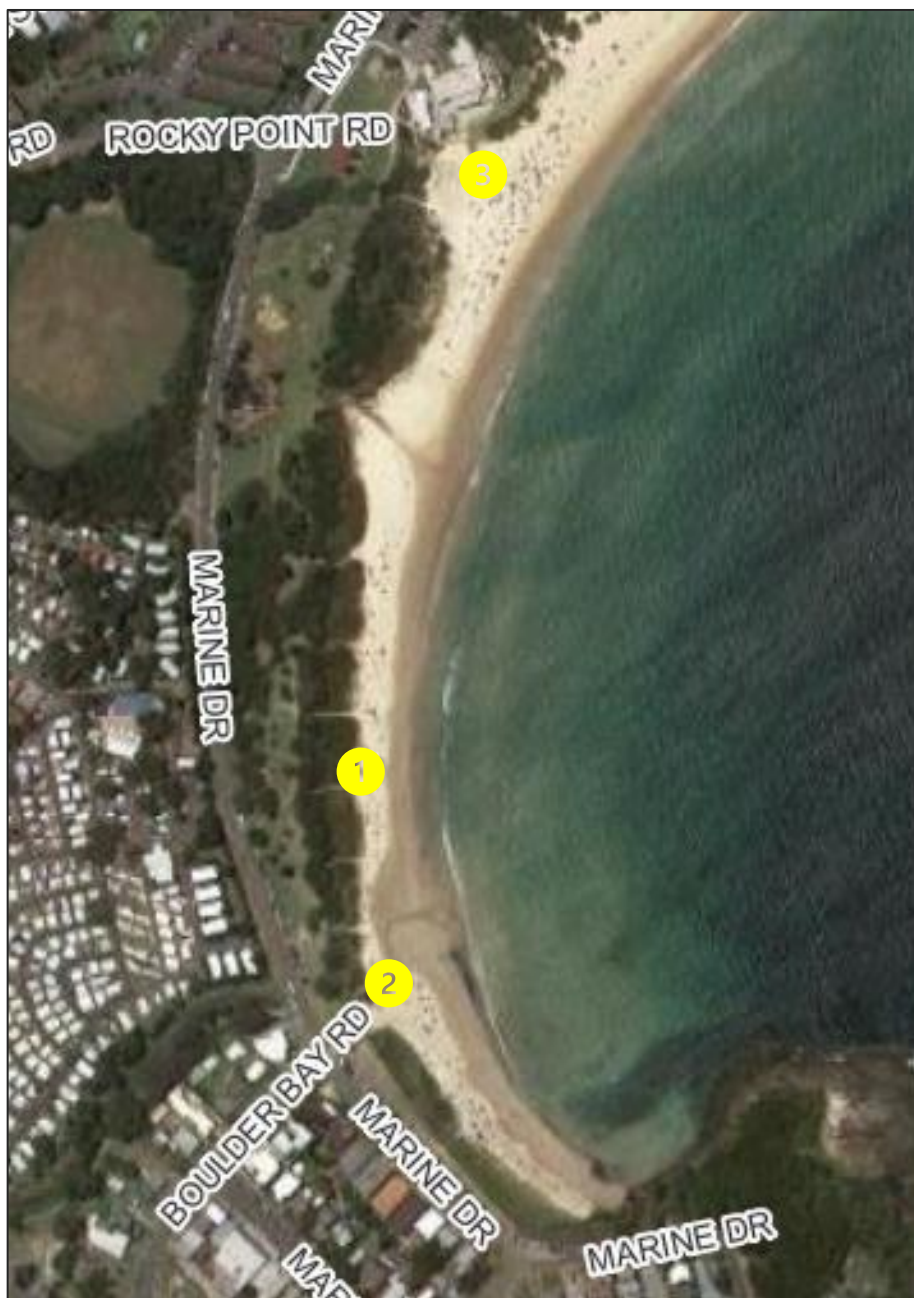
Figure D-4 – Fingal Bay Sand Management Activities

1. Beach scraping is undertaken six times a year to address erosion at the base of each of the seven beach accessways at a cost of around \$3,000 each time.
2. Beach scraping to reprofile where erosion occurs near the stormwater outlet near Boulder Bay Road, impacting access via the boat ramp at a cost of around \$3,000 each time. Undertaken concurrent with beach scraping at the accessways.
3. Beach scraping near the SLSC where sand accumulates near the roller doors and makes access difficult. Undertaken roughly twice a year at an estimated cost of \$3,000.

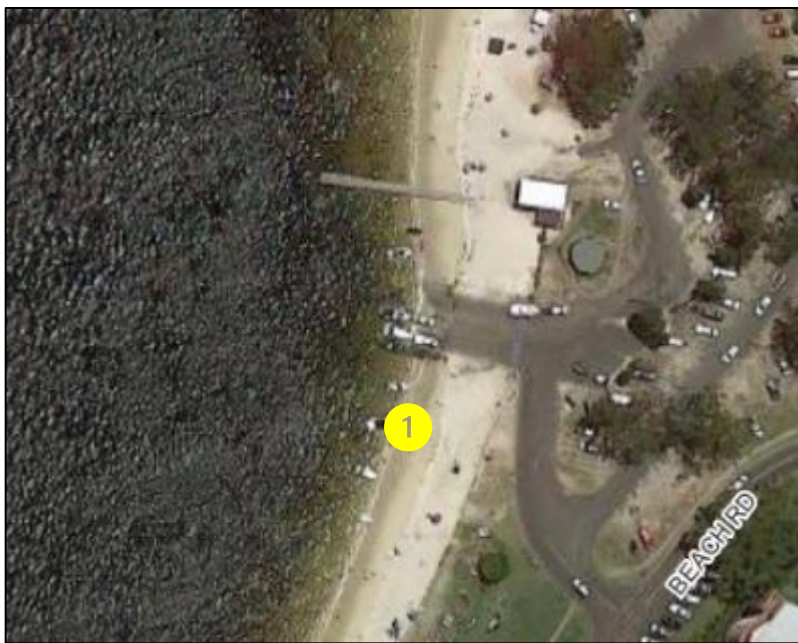
**Figure D-5 – Little Beach Dredging / Sand Source**

1. Dredging of sand from below MHWL around the boat ramp, as provided for under Action RA045. Typical volumes of 80-100 m<sup>3</sup> are dredged, and the sand is placed downdrift of the boat ramp, or if it is not required in this location, placed on Nelson Bay Beach adjacent to the splash park where erosion occurs.

1. Placement location for sand dredged from the Little Beach boat ramp or Nelson Bay Marina under Action RA045.

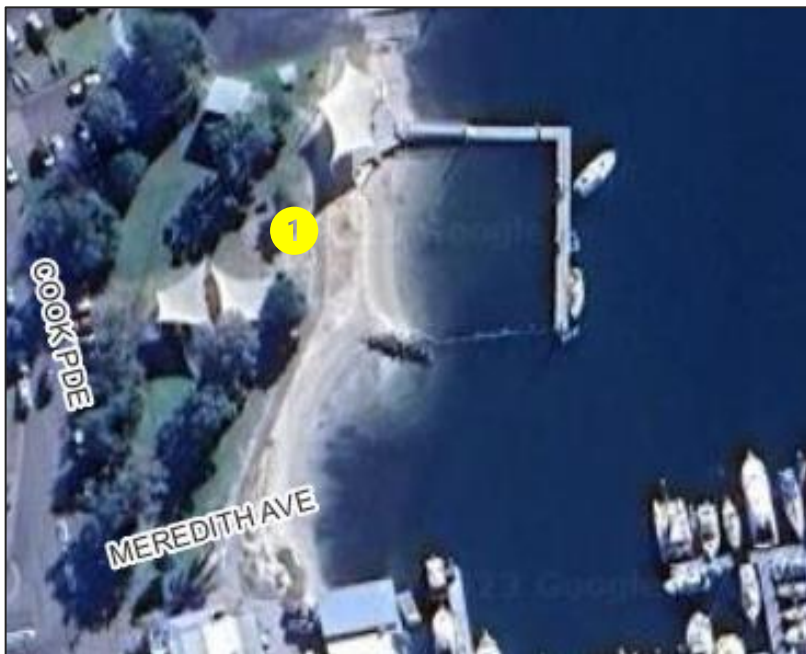
**Figure D-7 – Lemon Tree Passage, Sand Accretion**

1. Sand accrues in the park next to the swimming enclosure and on the shared user path. The accumulation of sand can clog the irrigation system. This activity involves the removal of accumulated sand and is undertaken roughly every five years at a cost of around \$5,000 each time.

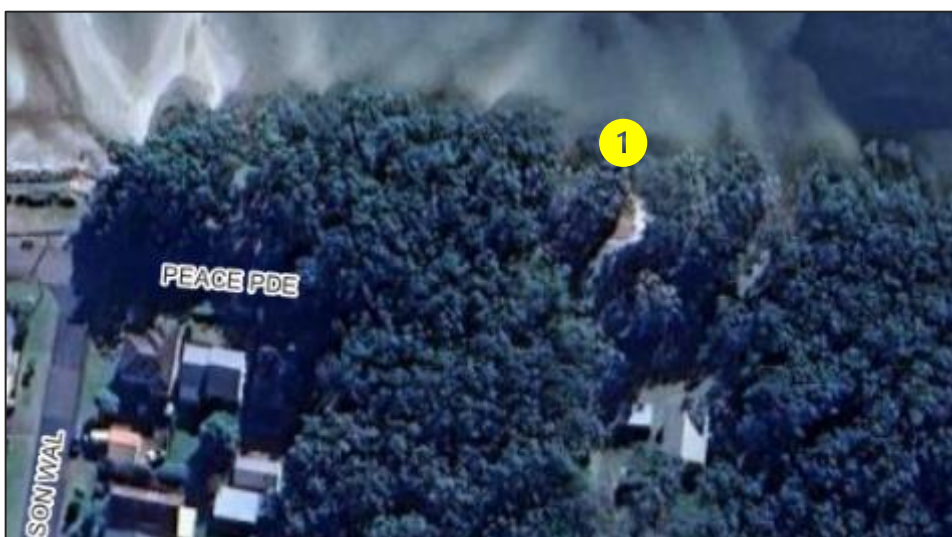
**Figure D-8 – Tanilba, Minor Nourishment**

1. Minor nourishment (around 3 m<sup>3</sup>) is undertaken near the Sailing Club every two years to address erosion and improve access. The sand is sourced from a commercial provider and placed at the site at a cost of around \$100 each time.
